**UNDERWATER INVESTIGATION
OF
STRUCTURE NO. 101-6132
MORGAN STREET
OVER THE
ROCK RIVER
IN
ROCKFORD, ILLINOIS**

AUGUST 2005

Prepared by:
COLLINS ENGINEERS, INC.
123 North Wacker Drive, Suite 300
Chicago, IL 60606

CEI JOB NO. 4538

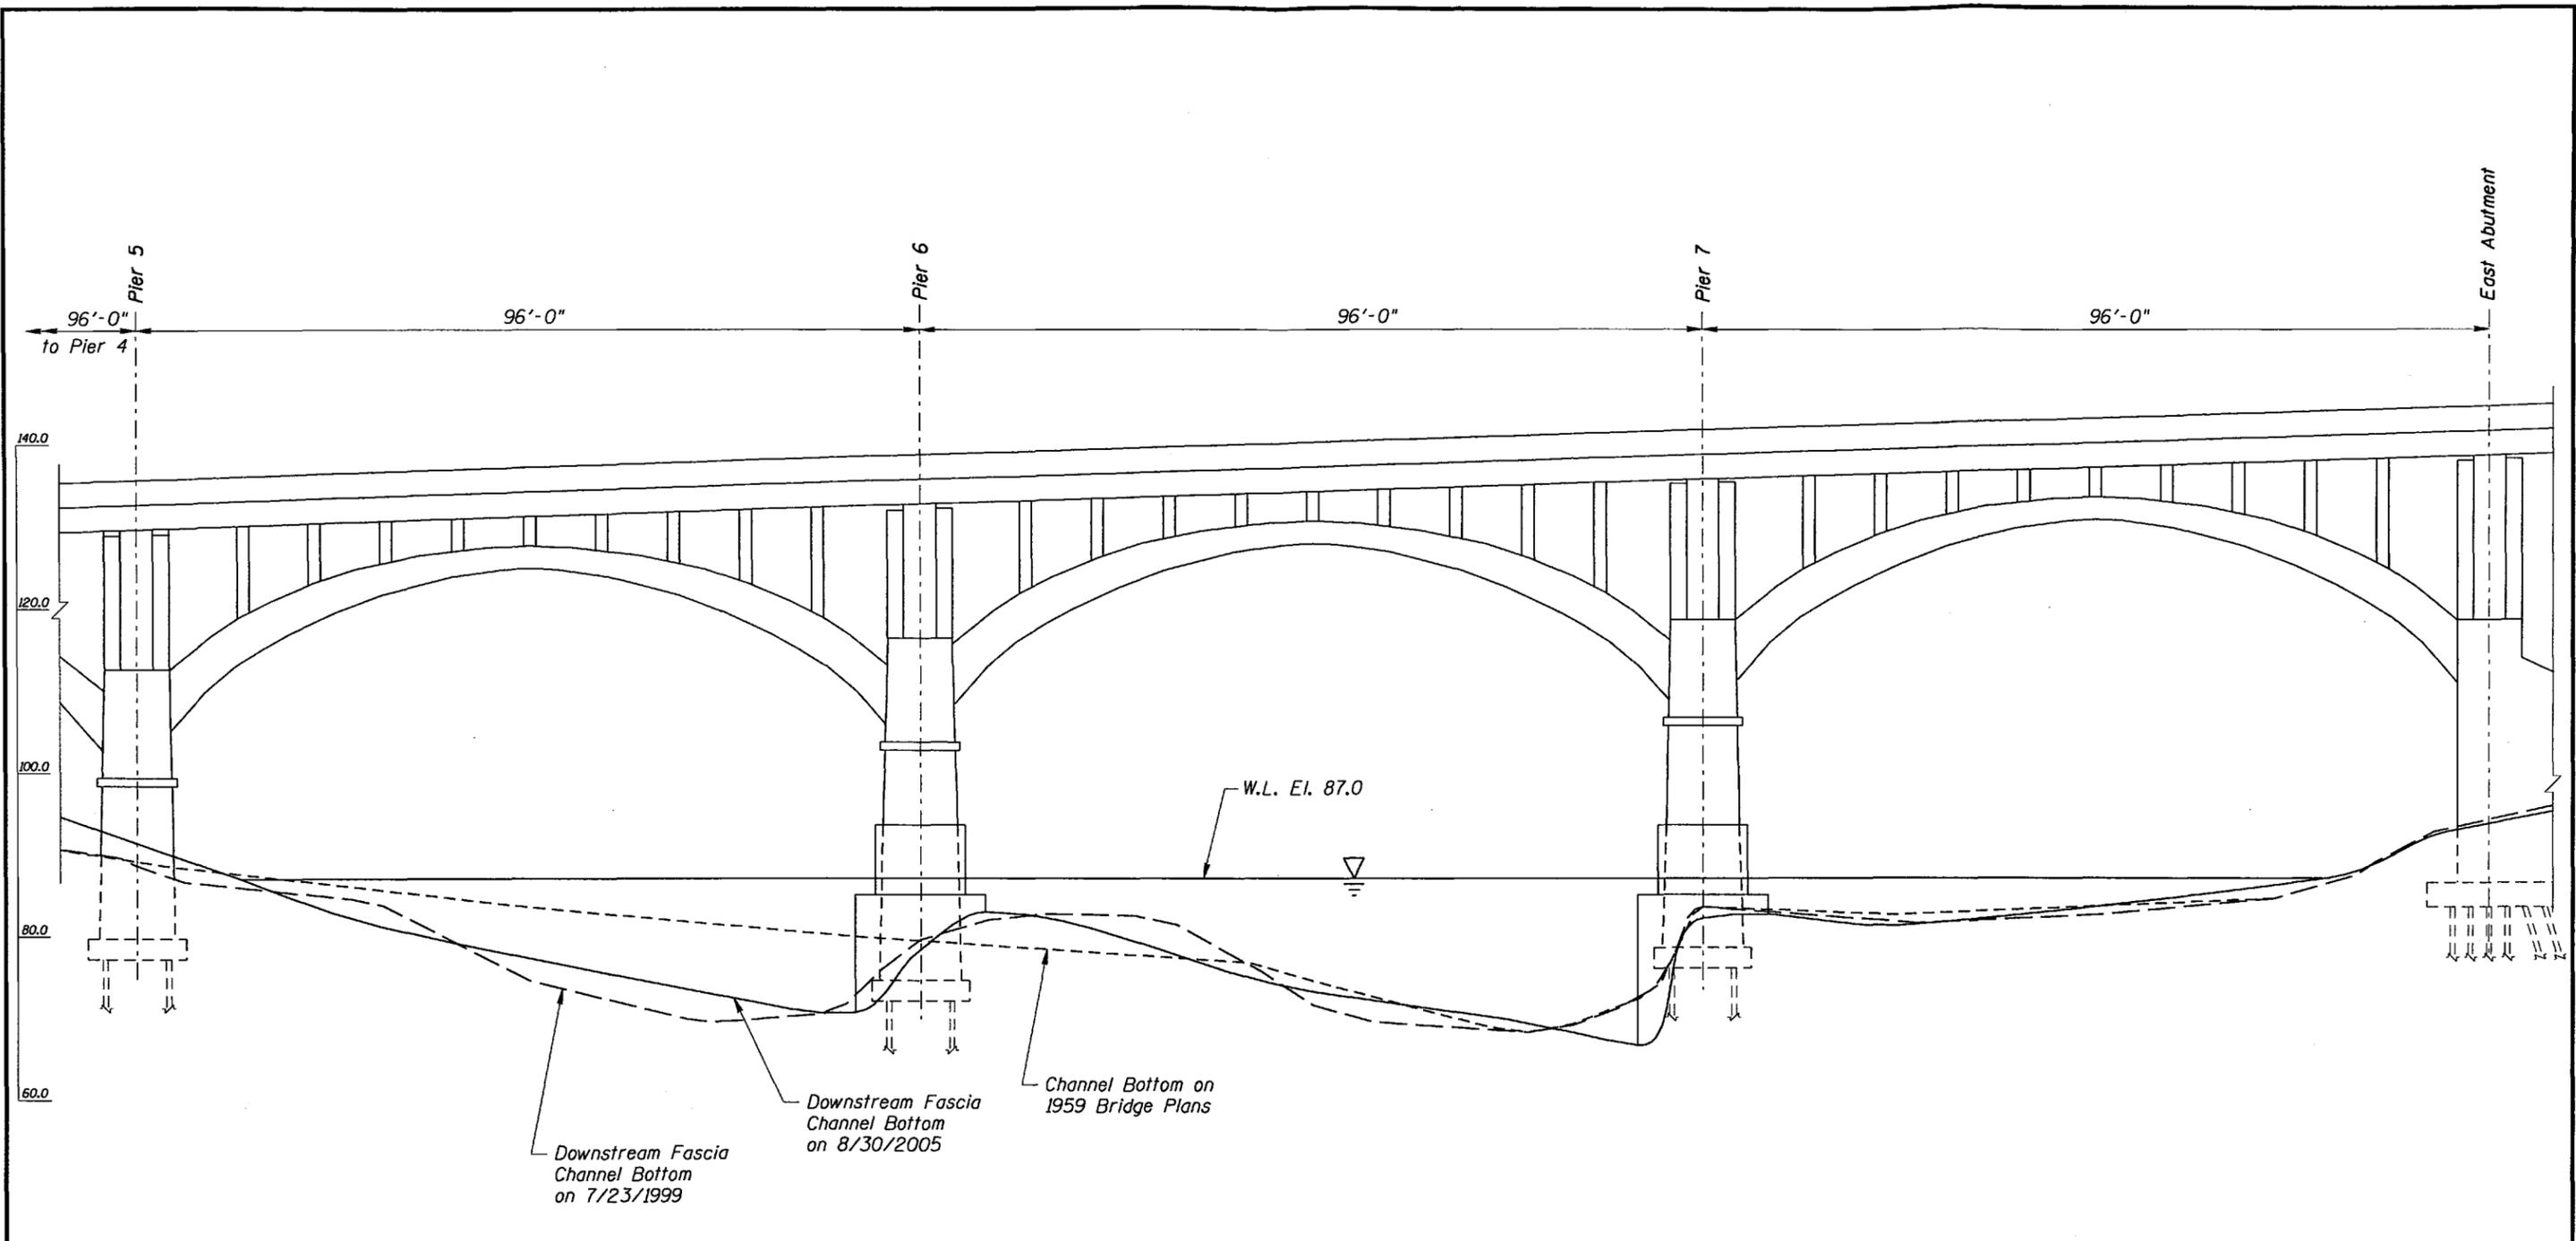
<small>123 North Wacker Drive Suite 300 Chicago, IL 60606 (312) 704-9300 www.collinsengr.com ILLINOIS PROFESSIONAL DESIGN FIRM LICENSE NO. 184-000993</small>	Date: SEPT., 2005
Checked By: JEO		Scale: 1"=20'-0"
Code: 45380001		Figure No.: 3

Comparing the soundings taken to those taken in 1999 indicates that the channel bottom along the downstream fascia of the structure has remained fairly consistent, while the channel bottom upstream and 50 feet downstream of the structure has remained consistent or filled in slightly. However, the soundings indicate that degradation of the channel bottom material has occurred 100 feet and 200 feet downstream of the structure. It should also be noted that the channel bottom elevations around the substructure units have also remained fairly consistent over the last 6 years. Refer to Figure 3 in Appendix A for a comparison of the channel bottom contour along the downstream fascia.

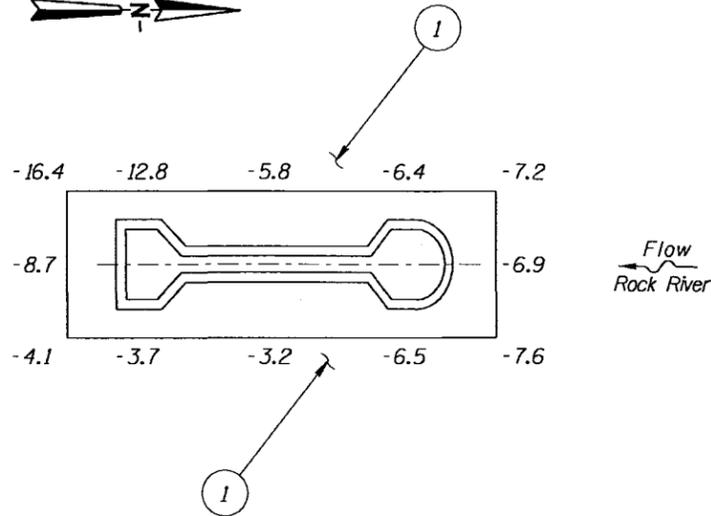
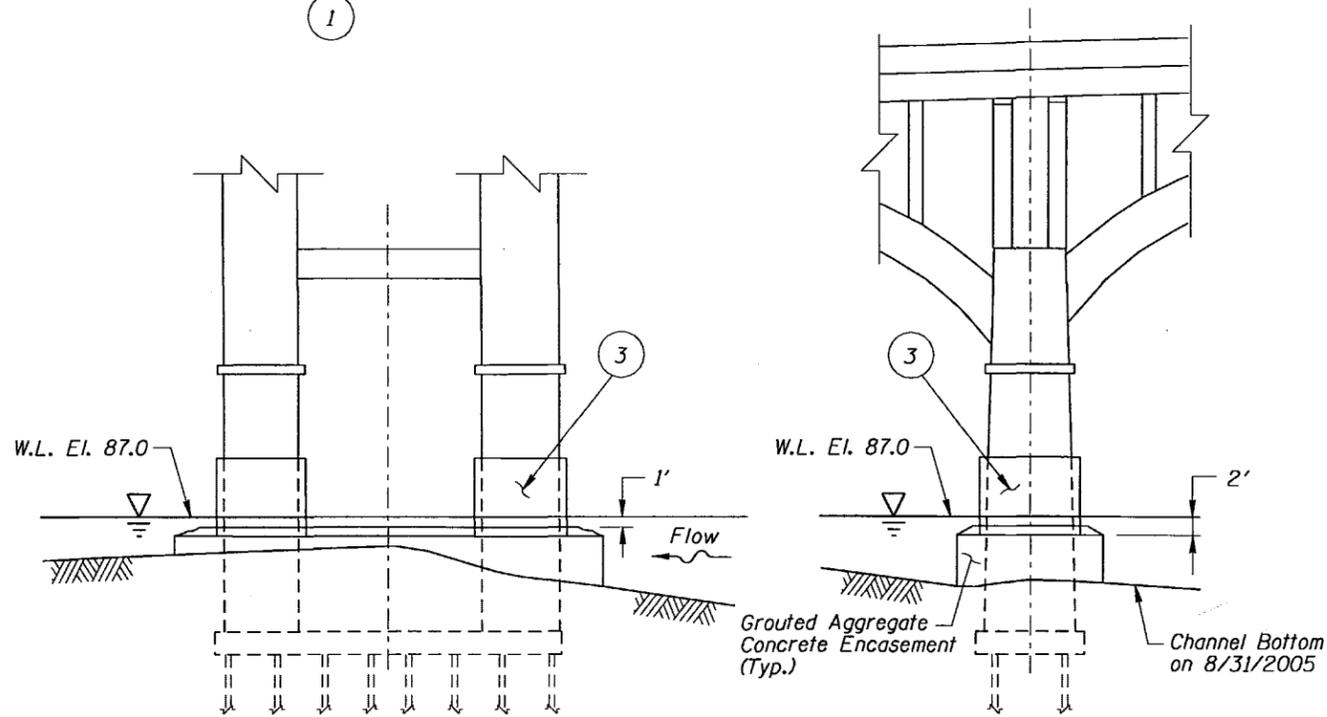
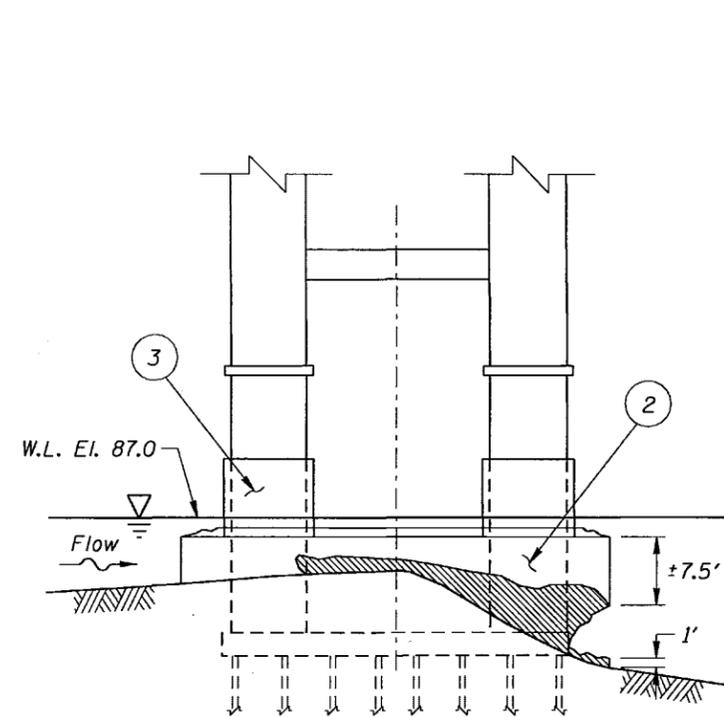
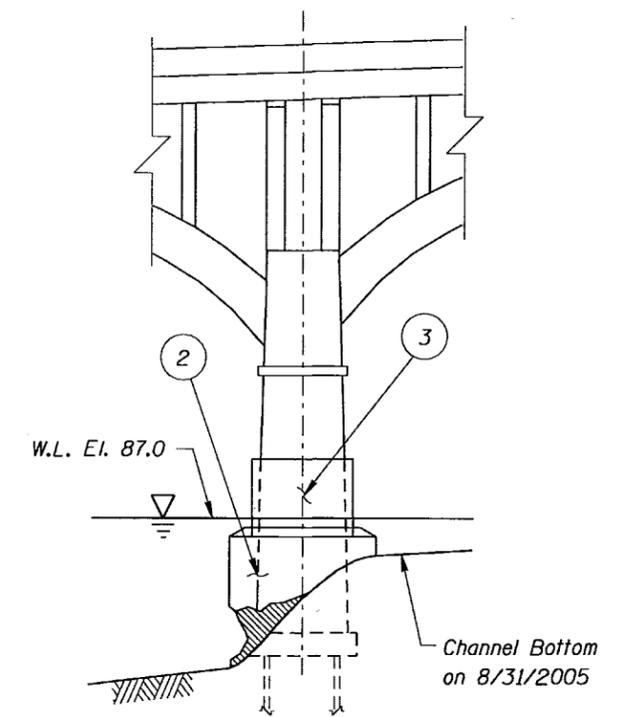
PIER 6 - INSPECTION NOTES

Pier 6 was generally in fair condition below water. A scour countermeasure, which was placed around the pier in 1959, consisted of a grouted aggregate concrete encasement with the vertical sides formed by a sheet piling cofferdam driven into the existing channel bottom. The top of the grouted aggregate concrete was located 1 to 2 feet below the waterline around the pier perimeter. This encasement was in poor condition with heavy section loss along the west side of the pier. Large voids were visible in the vertical encasement face, extending from the center of the upstream column on the west fascia to the downstream nose. The areas of encasement section loss typically extended from the channel bottom to 2 feet below the top of the encasement along the upstream fascia and from 1 foot above the channel bottom to 7.5 feet below the top of the encasement along the downstream fascia and downstream nose. At the southwest corner of the pier where the section loss was heaviest, the void exhibited up to 6 feet of penetration. However, the diver did not observe any timber piles around the perimeter of the pier in accessible areas. Above water, the pier exhibited vertical cracks and map cracking with exudation, measuring up to 1/16-inch wide. In addition, random areas of delaminated concrete and associated section loss were also observed around the perimeter of the pier wall. Refer to Figure 4 in Appendix A for the Pier 6 Plan, Elevations and Inspection Notes.

At both piers, the encasement section loss was heaviest at the southwest corner, where Pier 6 had up to 6 feet of penetration and Pier 7 had up to 5 feet of penetration. At both locations, the diver was unable to detect any exposed timber piles in accessible areas. Areas that were not accessible included smaller voids that did not allow for tactile examination of the substructure concrete.

- 1 The channel bottom material typically consisted of concrete rubble with interspersed construction debris, having no probe rod penetration possible.

- 2 The grouted aggregate concrete encasement was in poor condition with heavy section loss along the west side of the pier. Large voids were visible in the vertical encasement face, extending from the center of the upstream column on the west fascia to the downstream nose. The areas of encasement section loss typically extended from the channel bottom to 2 feet below the top of the encasement along the upstream fascia and from 1 foot above the channel bottom to 7.5 feet below the top of the encasement along the downstream fascia and downstream nose. At the southwest corner of the pier where the section loss was heaviest, the void exhibited up to 6 feet of penetration. However, the diver did not observe any timber piles around the perimeter of the pier in accessible areas.

- 3 Above water, the pier exhibited vertical cracks and map cracking with exudation, measuring up to 1/16-inch wide. In addition, random areas of delaminated concrete and associated section loss were also observed around the perimeter of the pier wall.

Based on conversations with CMT personnel, the Morgan Street Bridge will be replaced within the next 5 years. If complete replacement of the bridge occurs within the next 5 years, then no structural repairs to the scour countermeasures will be necessary. However, based on the encasement condition and noted high water velocity on the Rock River, it is recommended that the Morgan Street Bridge be inspected underwater at intervals not to exceed 12 months until the bridge is replaced. Underwater inspections will help document further deterioration of the encasements that may allow for undermining of the concrete footings. Should the life of the structure be prolonged over 5 years, it is recommended that the encasements be repaired, or new scour countermeasures be installed. It is also recommended that the noted cracks and areas of section loss above water also be repaired.

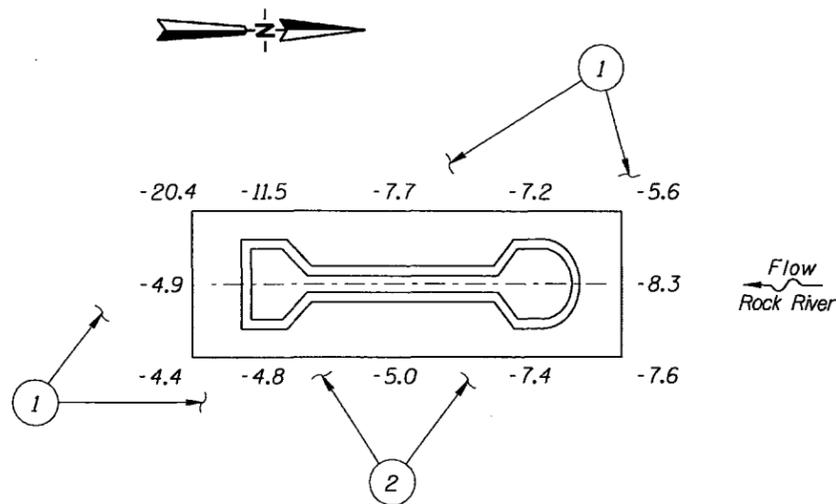
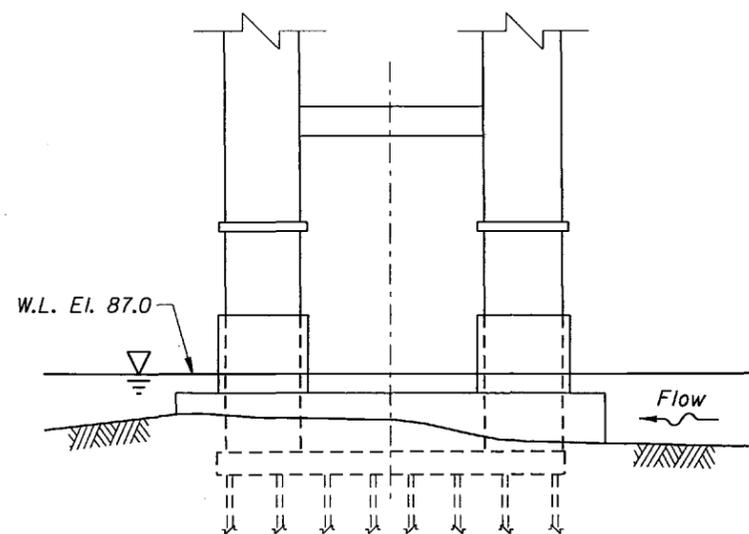
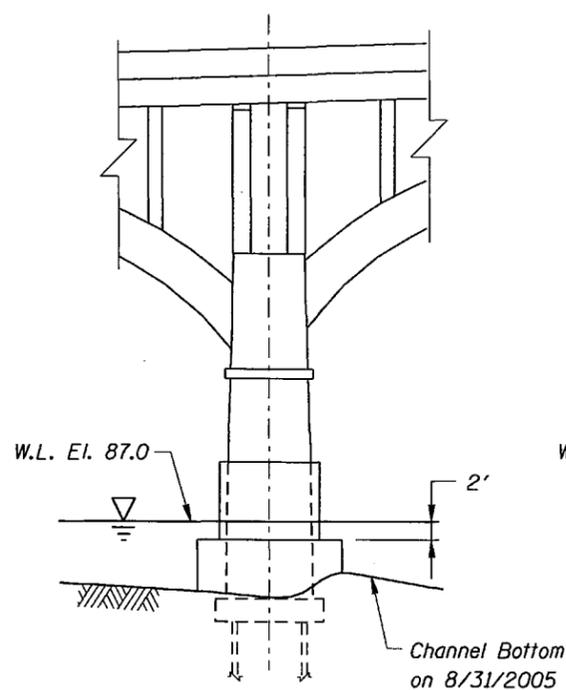
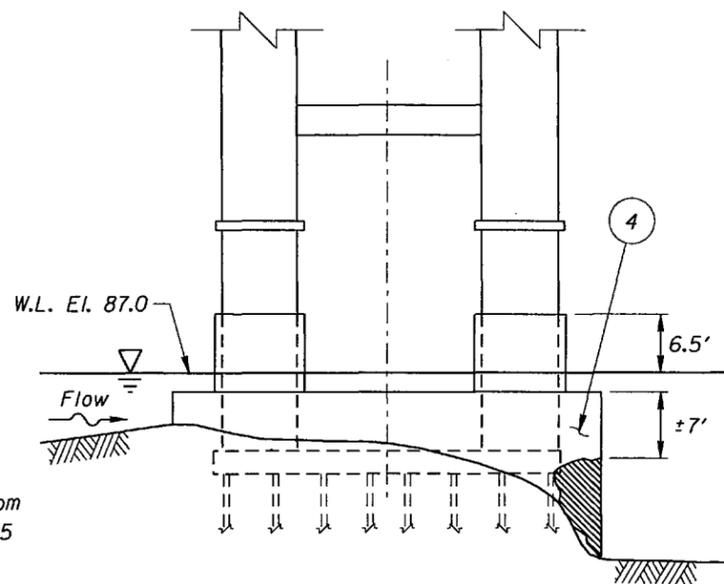
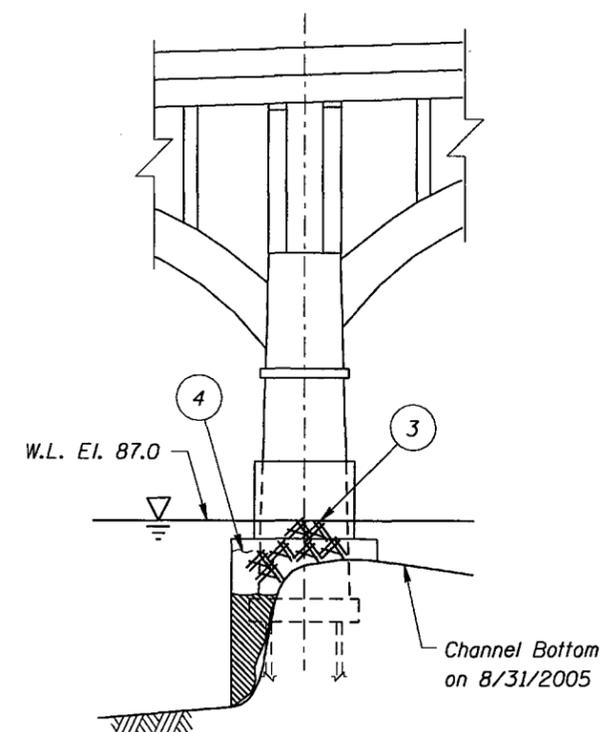
MORGAN STREET BRIDGE
OVER THE ROCK RIVER
IN ROCKFORD, ILLINOIS
STRUCTURE NO. 101-6132
PIER 7 - INSPECTION NOTES

Pier 7 was generally in fair condition below water. A scour countermeasure, which was placed around the pier in 1959, consisted of a grouted aggregate concrete encasement with the vertical sides formed by a sheet piling cofferdam driven into the existing channel bottom. The top of the grouted aggregate concrete was located approximately 2 feet below the waterline around the pier perimeter. This encasement was in poor condition with heavy section loss along the west side of the pier. Large voids were visible in the southwest corner of the vertical encasement face, extending from the channel bottom to 7 feet below the top of the encasement. At the southwest corner of the pier where the section loss was heaviest, the void exhibited up to 5 feet of penetration. However, the diver did not observe any timber piles around the perimeter of the pier in accessible areas. Above water, the pier exhibited vertical cracks and map cracking with exudation, measuring up to 1/16-inch wide. In addition, random areas of delaminated concrete and associated section loss were also observed around the perimeter of the pier wall. Refer to Figure 5 in Appendix A for the Pier 7 Plan, Elevations and Inspection Notes.

- ① The channel bottom material typically consisted of concrete rubble with interspersed construction debris, having no probe rod penetration possible.

- ② The channel bottom material along the east side of the pier between the columns typically consisted of sandy gravel with up to 2 inches of probe rod penetration.

- ③ Heavy accumulation of timber debris, extending from the channel bottom up 6 feet. This debris consisted of trees measuring up to 8 inches in diameter with associated branches.

- ④ The grouted aggregate concrete encasement was in poor condition with heavy section loss along the west side of the pier. Large voids were visible in the southwest corner of the vertical encasement face, extending from the channel bottom to 7 feet below the top of the encasement. At the southwest corner of the pier where the section loss was heaviest, the void exhibited up to 5 feet of penetration. However, the diver did not observe any timber piles around the perimeter of the pier in accessible areas.

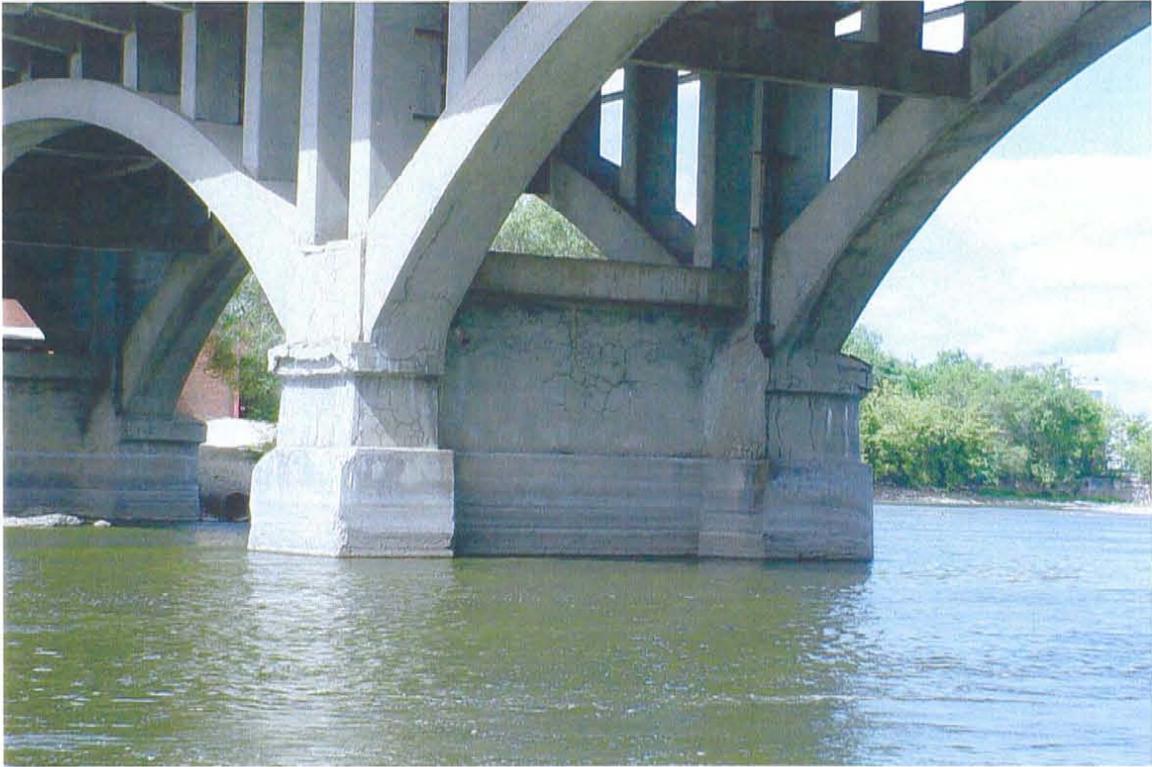
The channel bottom material around Pier 6 typically consisted of concrete rubble with interspersed construction debris, having no probe rod penetration possible. Refer to Photographs 3 through 5 in Appendix B for views of Pier 6.

Photograph 3. View of Pier 6, Looking Northwest.

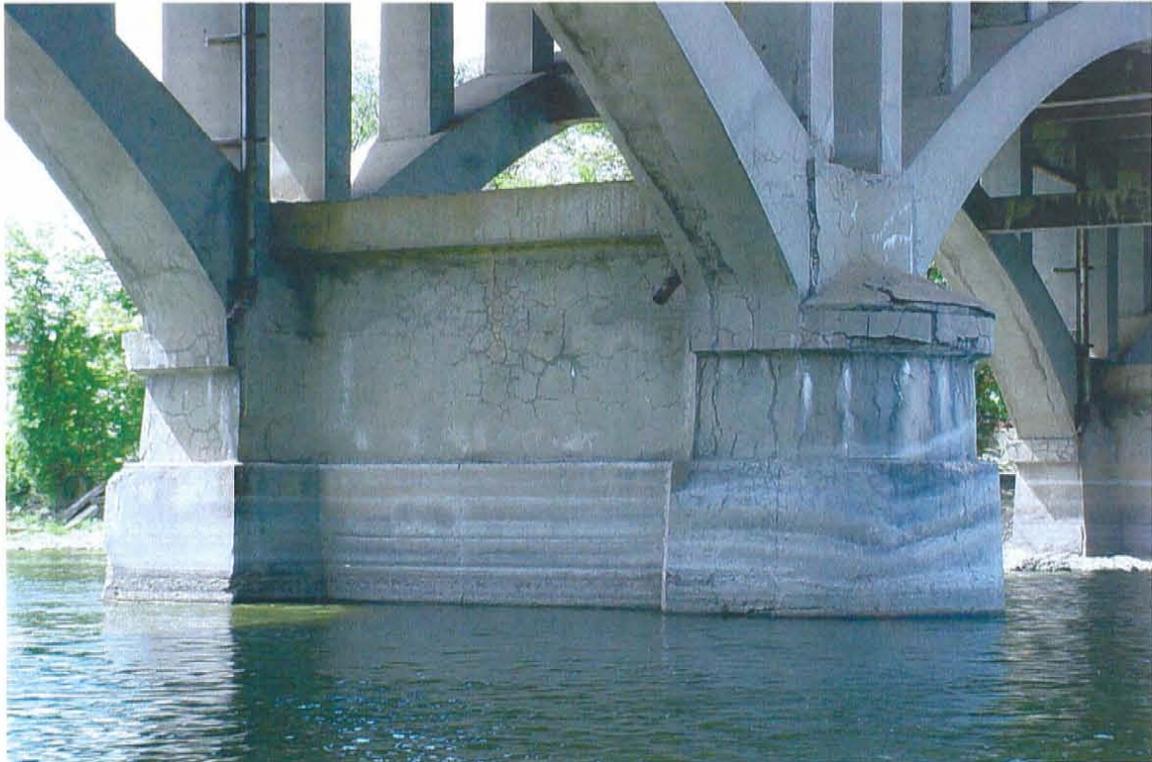
Photograph 4. View of Pier 6, Looking Southwest.

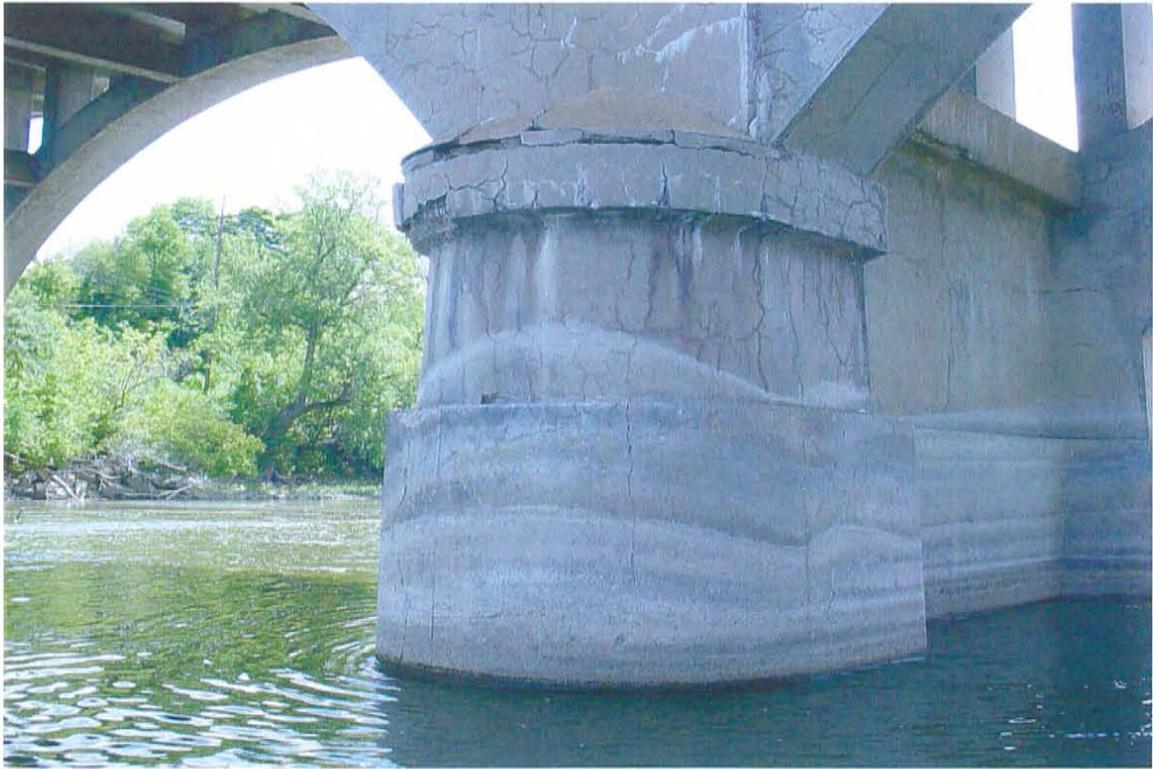
Photograph 5. View of Pier 6, Looking Southeast.

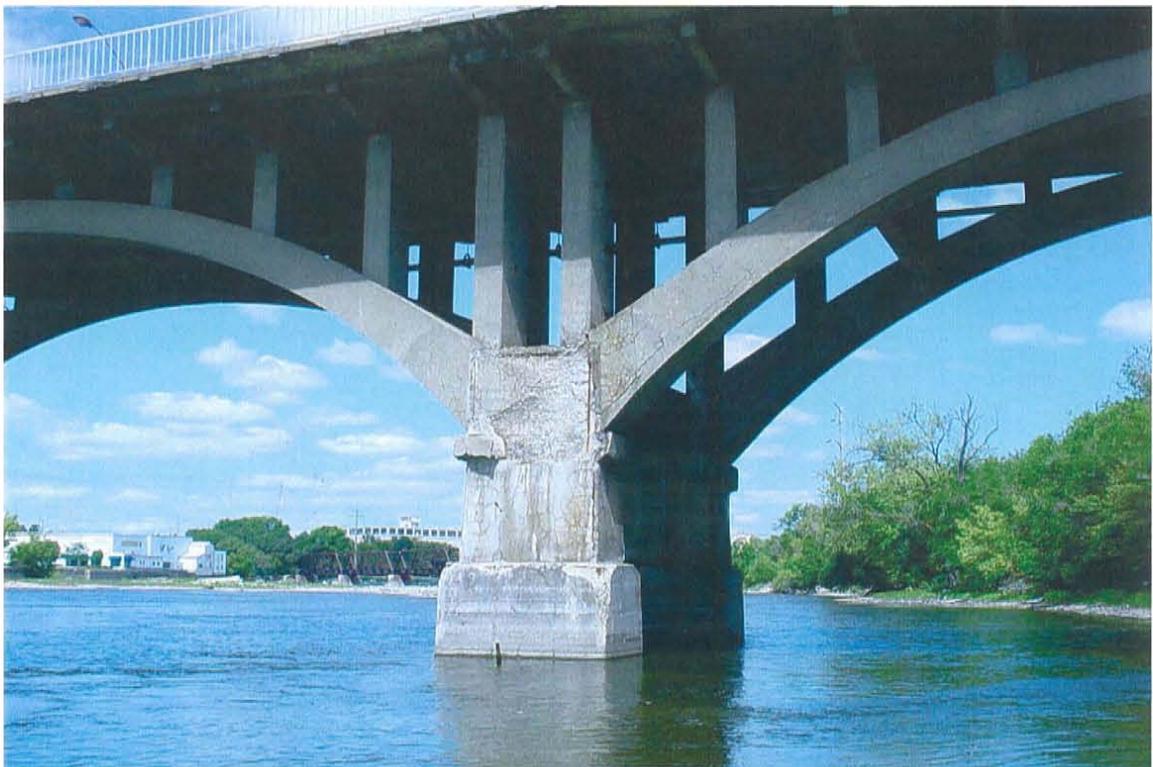
The channel bottom material around Pier 7 typically consisted of concrete rubble with interspersed construction debris, having no probe rod penetration possible. Along the east side of the pier between the columns, the channel bottom material typically consisted of sandy gravel with up to 2 inches of probe rod penetration. A heavy accumulation of timber debris was located along the downstream nose, extending from the channel bottom up 6 feet. This debris consisted of trees measuring up to 8 inches in diameter with associated branches. Refer to Photographs 6 through 9 in Appendix B for views of Pier 7.

Photograph 6. View of Pier 7, Looking Northwest.

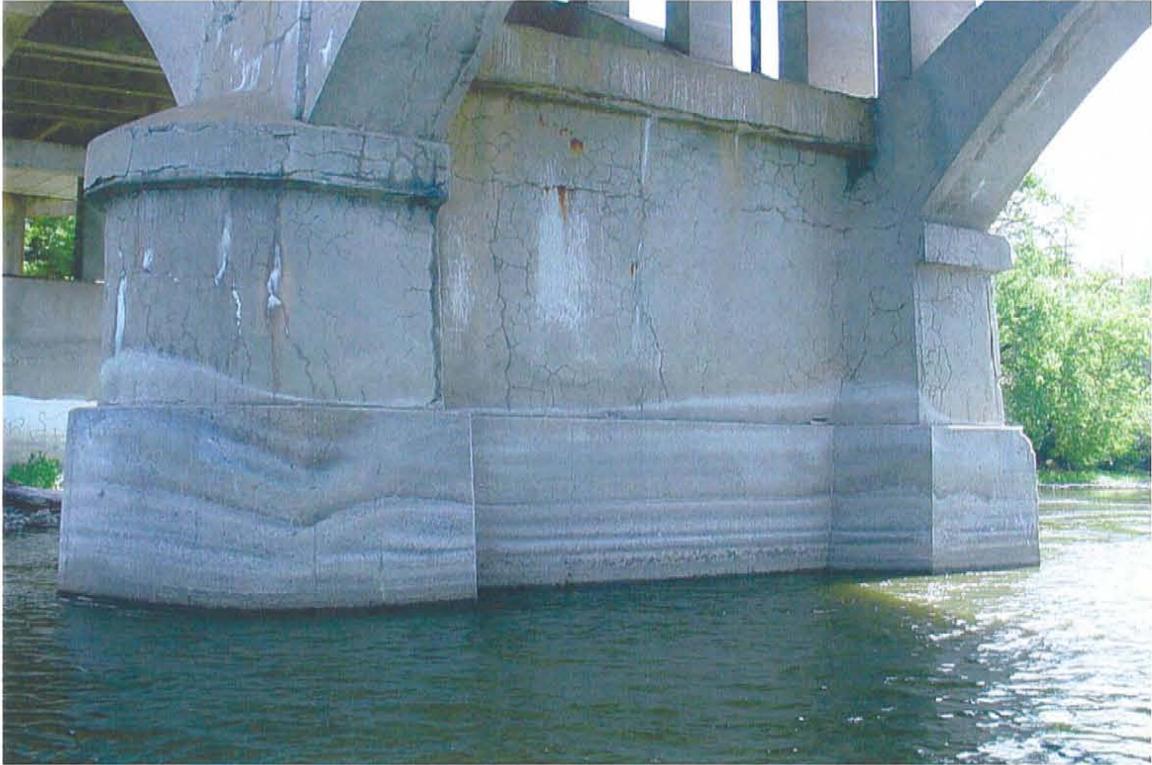
Photograph 7. View of Pier 7, Looking Southeast.

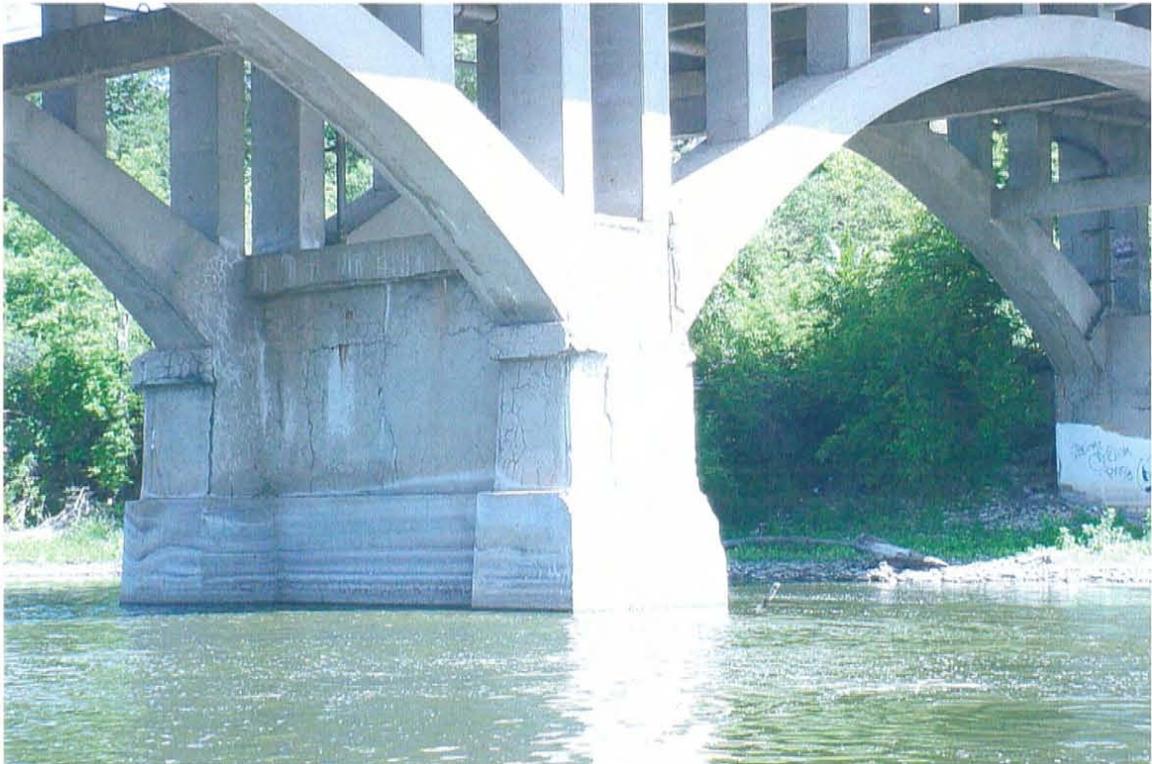
Photograph 8. View of Pier 7, Looking Northwest.

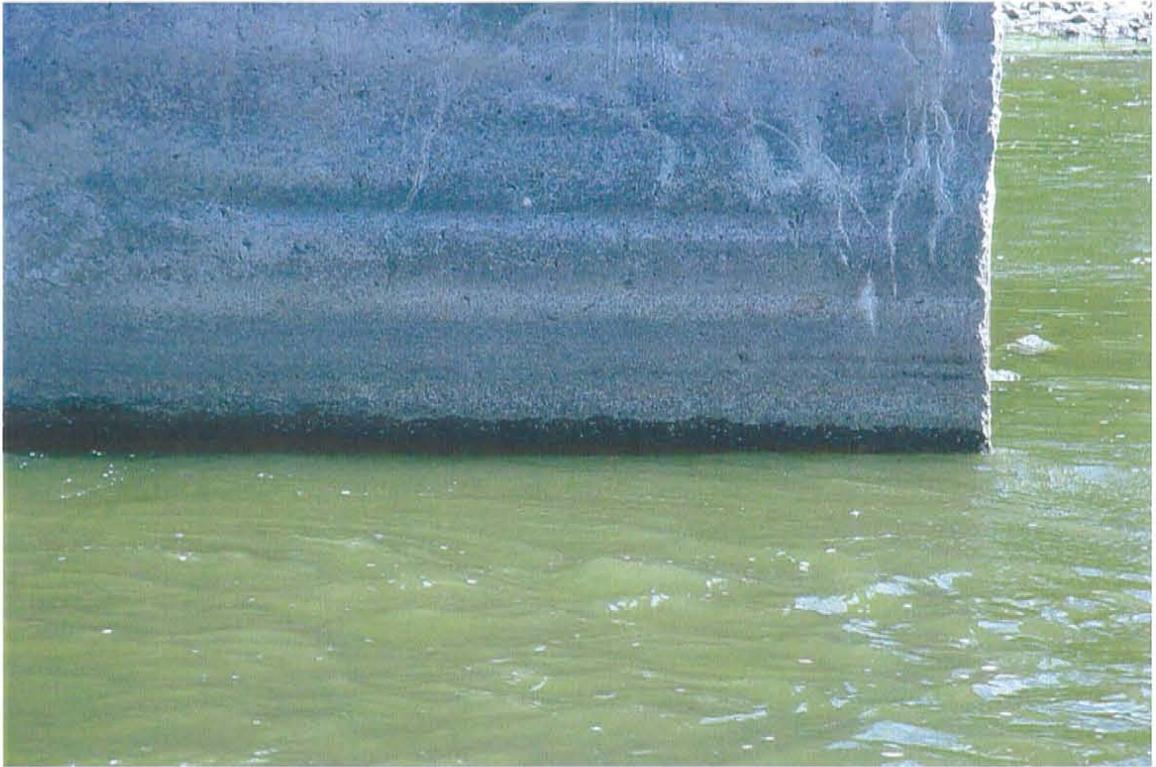
Photograph 9. View of Pier 7, Looking East. Note Typical Concrete Condition Along Waterline.
