City of ROCKFORD

ILLINOIS URBAN ARCHITECTURAL AND HISTORICAL SURVEY CONTINUATION SHEET

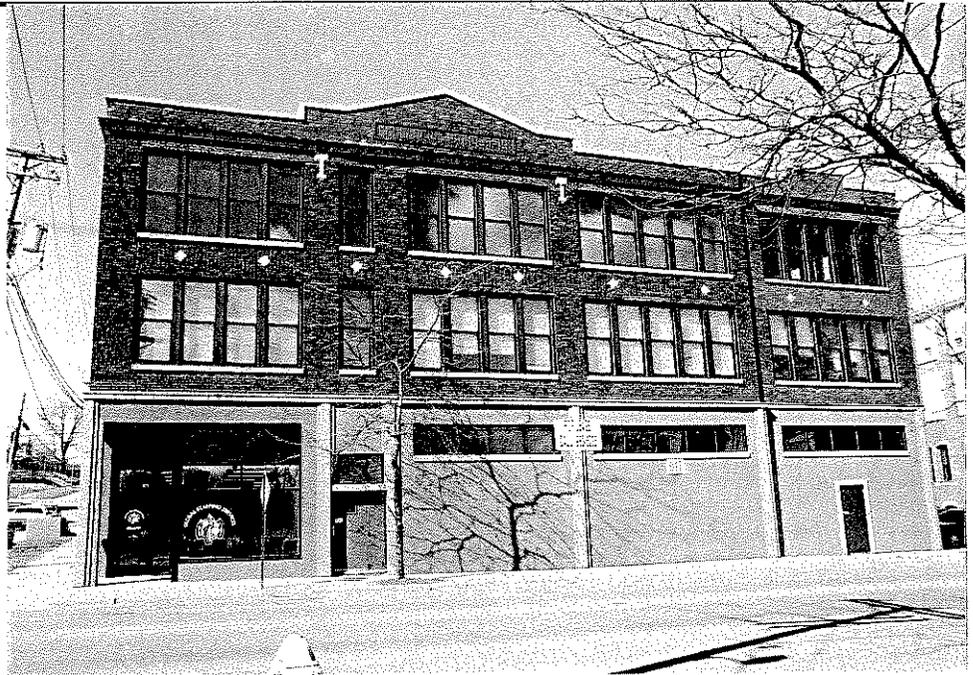
Stone lintel above all storefronts; 4 storefronts on east facades (one corner); front entry to upper levels in second story bay

completely altered storefronts in configuration and materials; materials include dryvit, aluminum windows, doors; cedar panels on front of windows [Permit #B82-763 (1982)]

No permit # (1991)--demo garage

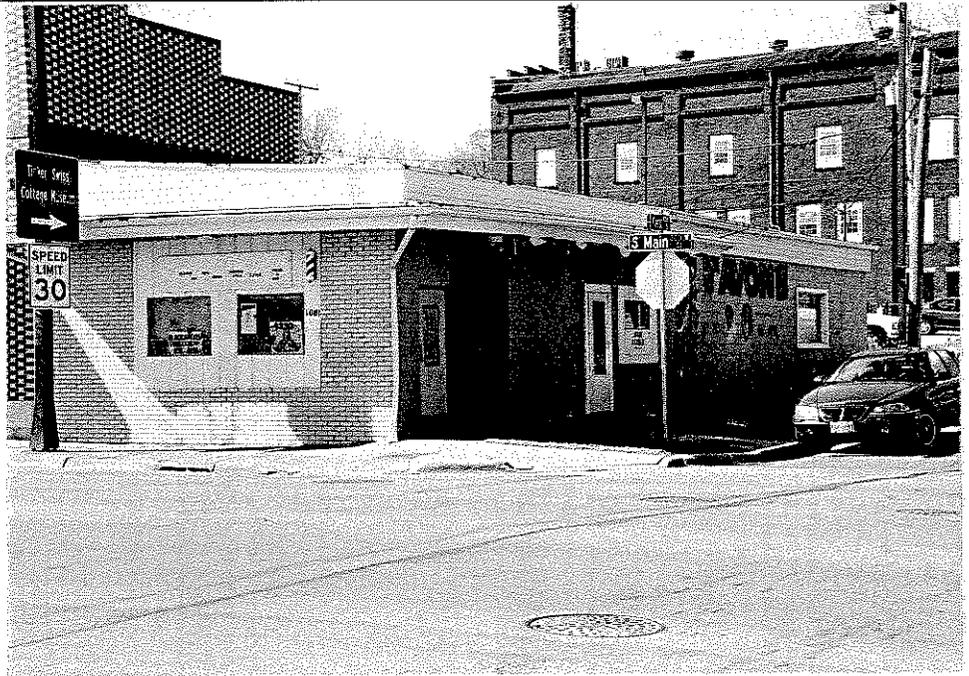
Display window opening on east front facade; recessed entry at east end of north facade

Secondary entry and display window on north facade now blocked in; aluminum siding at roofline; downsized display windows framed with wood vertical boards in original openings; downsized door opening with vertical boards

#5138 (1933)--demo 2 story brick store; #36765 (1970)--remove wood windows and block w/ masonry; #41312 (1973)--cut opening and install overhead door; Building Dept. notice (1984)--remodeled into barber shop & store without permits; B85-353 (1985)--remove plate glass, framing in with 2'x4' frame

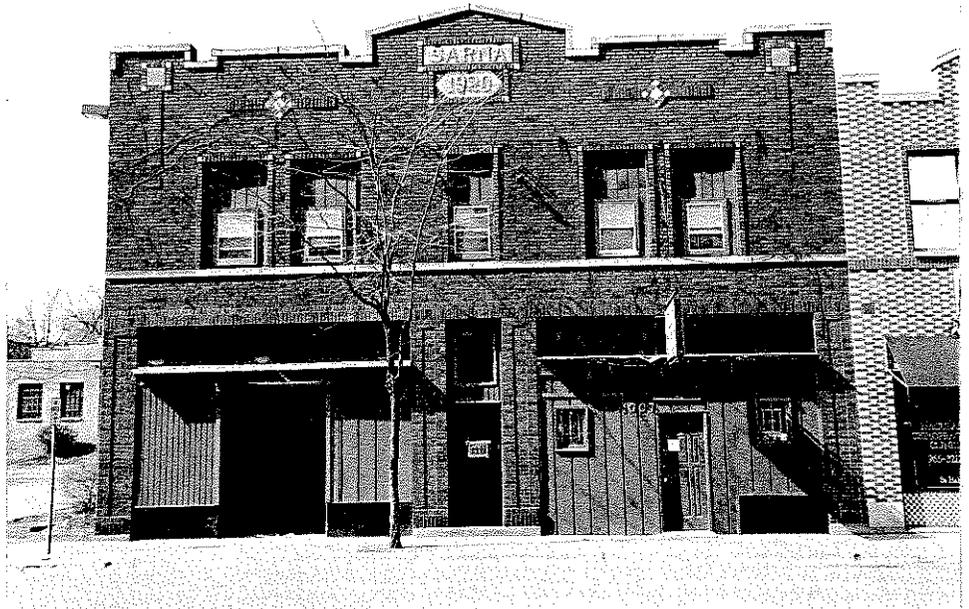
ROLL1	3
FRAMES1	9
ROLL2	
FRAMES2	
ROLL3	
FRAMES3	
DIGITAL PHOTO ID	e:\main1009s.jpg

2 storefronts with recessed center entries; main entry to upper floors in center bay; black carrara glass at base of storefront; recessed brick panels on brick piers between bays; soldier course brick lintel across both storefronts and main entry

extensively altered storefronts; north storefront still has recessed entry but window area is filled with wood; south no longer has recessed entry; most Carrara glass gone, 2 small windows on either side of flush door; window area filled with wood

Original building permit #456 (3/11/1920)--"2 theatre & store"; Other permits: #21776 (1960)--close door & wall openings with block; #84158 (1941)--remodel 1st floor for store

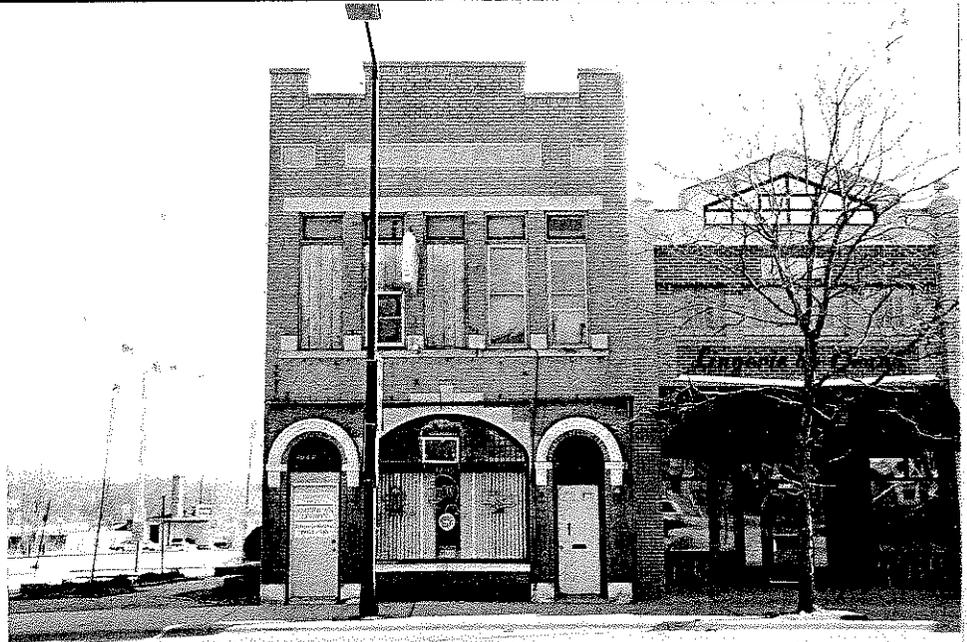
ROLL1	3
FRAMES1	19
ROLL2	
FRAMES2	
ROLL3	
FRAMES3	
DIGITAL PHOTO ID	e:\main1010s.jpg

1 storefront with entry at south end of front facade and center display window; main entry to upper floors on north end of front facade; arched transom over display windows & doors; stone hoods above doors; stepped stone decoration above center window

Aluminum replacement windows in original display window opening; replacement door in original openings; opening in display window transom made for air conditioner

Additional Permits--#741 (1920)--recover roof; #898 (1921)--remodel; #2738 (1926)--remodel (Bradley & Bradley, architects)

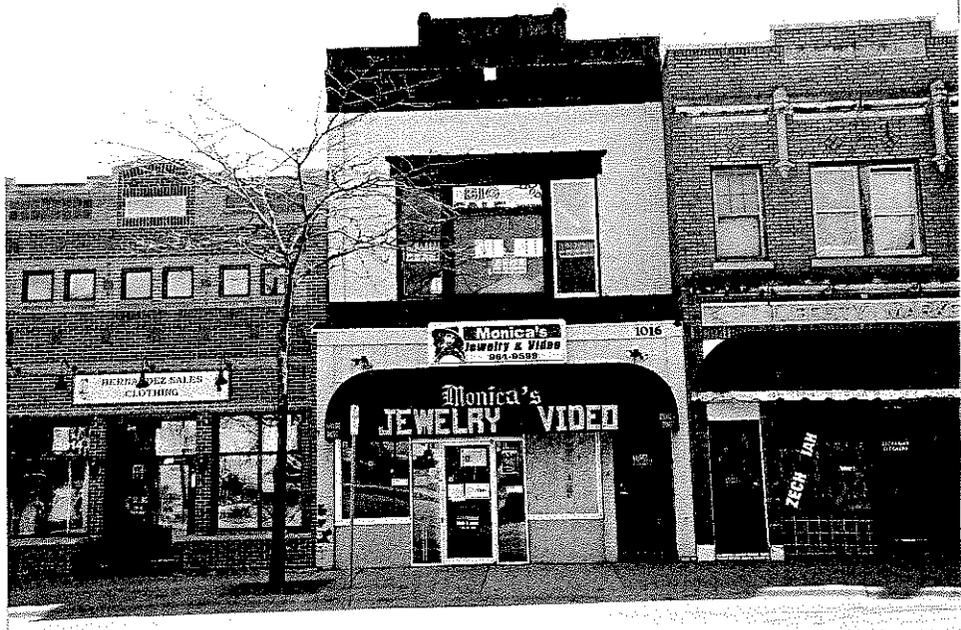
ROLL1	3
FRAMES1	16
ROLL2	
FRAMES2	
ROLL3	
FRAMES3	
DIGITAL PHOTO ID	e:\main1016s.jpg

completely altered storefront with new configuration and materials--storefront was renovated as City of Rockford Shopstead Project (Swanson Construction Co., contractor)

storefront renovated--one storefront with center entrance; main entry to upper level at south end of facade; wood vertical board on front facade; Aluminum display windows and door

Additional Permits--#4280 (1929)--remodel storefront; #3697 (1924)--cement block garage; B81-67 (1981)--repairs to meet code (\$45,000); B93-206--move front entry back

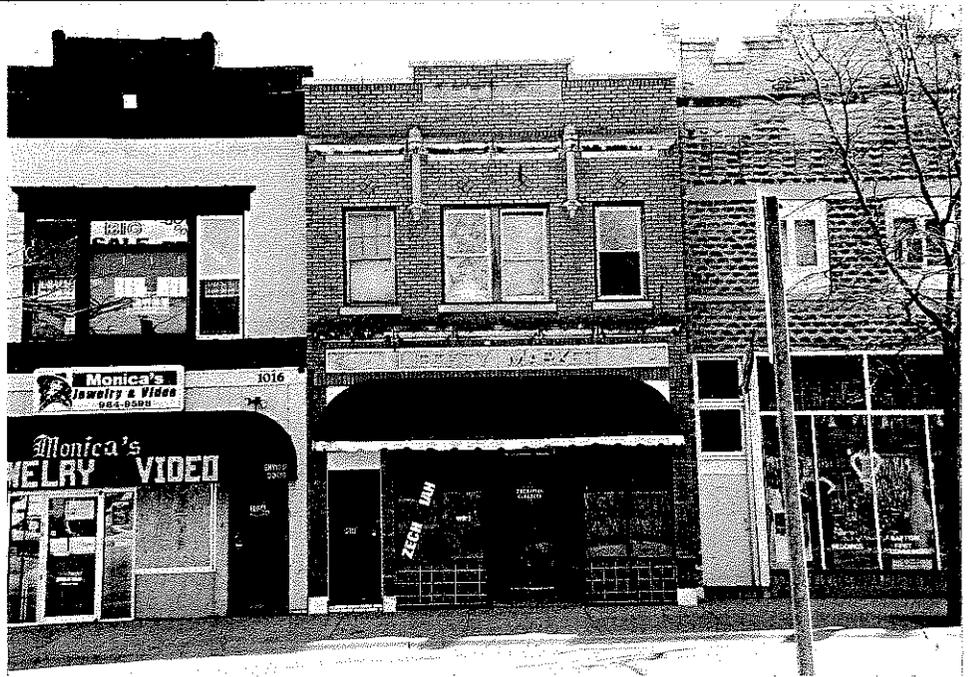
e:\main1018s.jpg

One storefront with original center recessed bay configuration

New materials on storefront, including tile bulkhead, Aluminum windows, wood panels on transom; new front & rear doors [permit #31107 (1966)]

Additional Permits -- #2305 (1926)--balcony; #3615 (1928)--
remodel 2 store fronts; #11223 (1946)--enclose 1st floor of rear
porch; #28955 (1965)--repair fire loss (\$400); #40774 (1973)--
interior remodel (\$5,000)

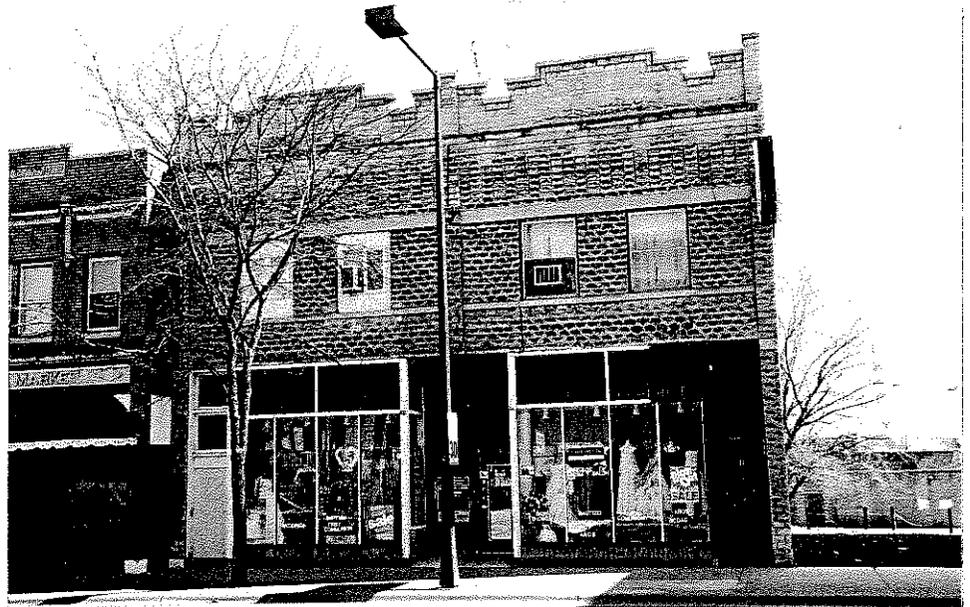
e:\main1020s.jpg

2 storefront with recessed entries side by side in center bay; south and north end entries to upper level; iron columns and parts of original iron window trim; prism glass in transoms above display windows

Store entrance altered, north entrance covered with vertical boards; vertical board at bulkhead; Aluminum display windows; transoms above doors boarded up

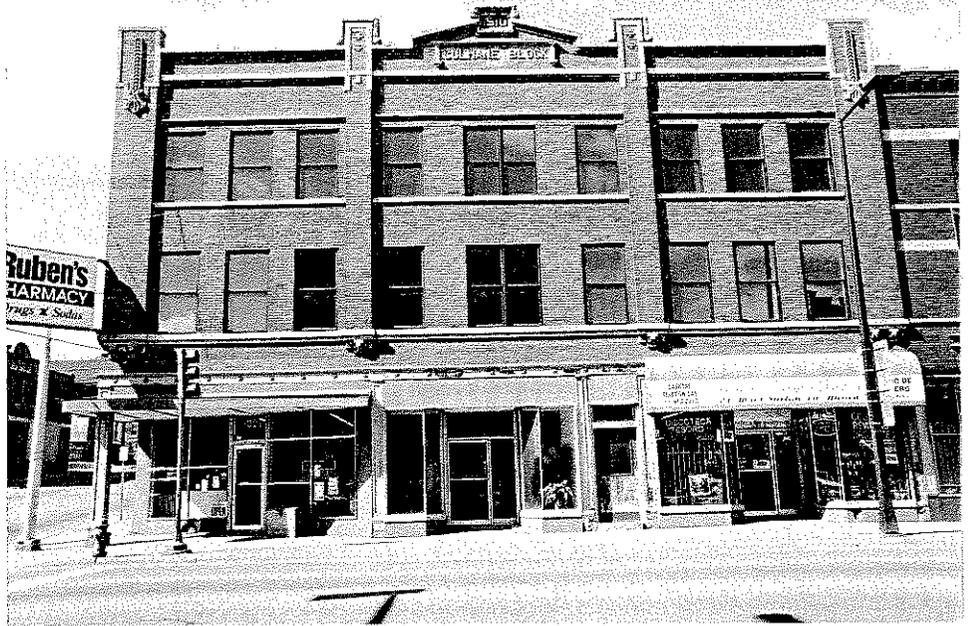
ARCHITECTURAL CLASSIFICATION Two Part Commercial Block PLAN square
 DETAILS Commercial Style NO OF STORIES 3
 BEGINYEAR 1910 ROOF TYPE Flat
 OTHER YEAR ROOF MATERIAL Not visible
 DATESOURCE South Main Street Survey FOUNDATION Concrete - poured
 WALL MATERIAL (current) Brick PORCH
 WALL MATERIAL 2 (current) WINDOW MATERIAL Aluminum
 WALL MATERIAL (original) Brick WINDOW MATERIAL
 WALL MATERIAL 2 (original) WINDOW TYPE double hung/fixe
 WINDOW CONFIG 1/1; single pane

ALTERATIONS Backlit sign; aluminum double hung replacement windows in original openings; windows boarded up on first floor of south facade; doors changed on south facade

Listed in 1997 as 1029 South Main Street---See continuation sheet for building permits for 1025, 1027, and 1029

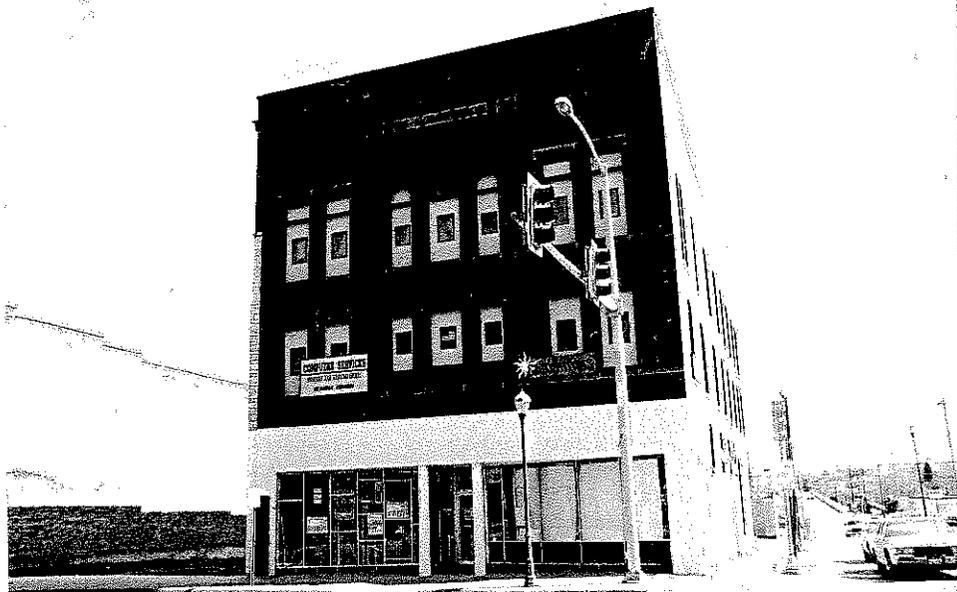
Additional Permits -- #3864 (1928)--rebuild parapet walls; #6714 (1937)--storefront (\$2000); #43301 (1974)--demo rear porch; #47443 (1976)--construct 15'x20' metal enclosure
