# City of ROCKFORD

## ILLINOIS URBAN ARCHITECTURAL AND HISTORICAL SURVEY CONTINUATION SHEET

STREET # 1303

STREET S MAIN ST

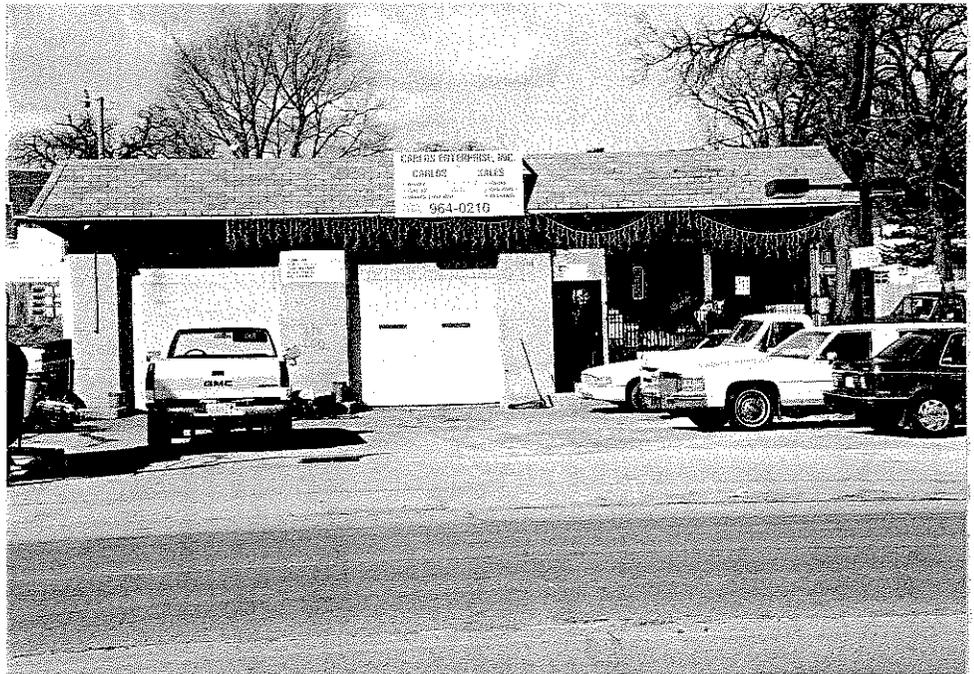
CATEGORY	<input type="text" value="building"/>	CURRENT FUNCTION	<input type="text" value="Transportation - auto repair/gas station"/>
CONDITION	<input type="text" value="fair"/>	HISTORIC FUNCTION	<input type="text" value="Transportation - auto repair/gas station"/>
INTEGRITY	<input type="text" value="major alterations and/or addition(s)"/>	REASON for SIGNIFICANCE	<input type="text"/>
STOREFRONT INTEGRITY	<input type="text"/>		
SECONDARY STRUCTURE	<input type="text" value="gasoline island"/>

On southwest corner of S. Main Street & Montague; on busy four lane state highway; mixed uses on street; parking pad, drive, and gas island at front; corrugated metal fencing around rear of building

painted steel panels; mansard roof added [permit #B83-709 (1983)--false roof overhang on 3 sides of building]; N. side window at corner enclosed w/ wood vertical board; replacement overhead garage doors (non-historic); metal security grates over main entry doors & windows; 2 entry doors for bathrooms on N. facade

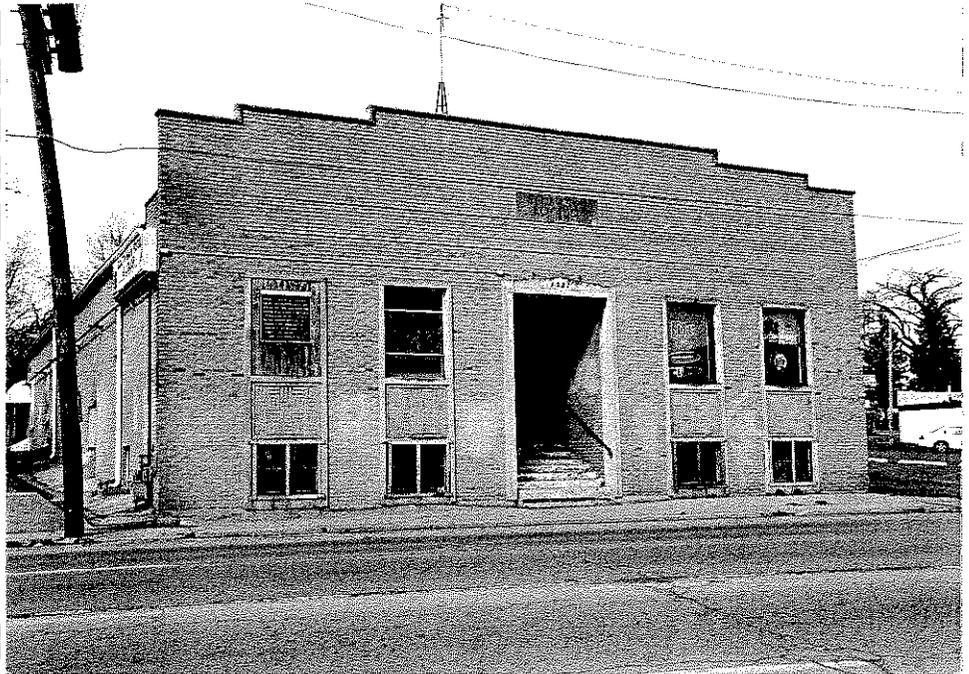
Mexican bar previous to liquor store; permit #33435 (1968)--  
general repairs (\$2500); permit #18992b (1956)--demo club  
rooms (brick)

brick cladding laid in English bond; basket weave brickwork panels below lower & upper level floor windows on front facade; recessed central entry up stairs with shallow pediment and paired wood doors with 3 diamond screen panels; stone window & entry surrounds; brick rowlock sills on north and south facades

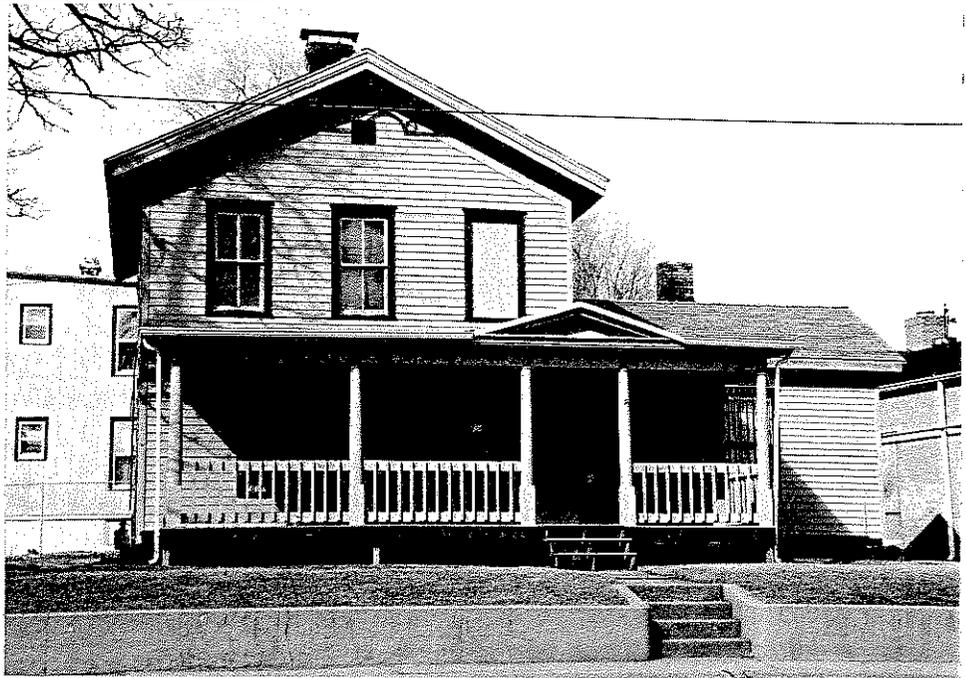
CATEGORY	<input type="text" value="building"/>	CURRENT FUNCTION	<input type="text" value="Domestic - multiple dwelling"/>
CONDITION	<input type="text" value="fair"/>	HISTORIC FUNCTION	<input type="text" value="Domestic - single dwelling"/>
INTEGRITY	<input type="text" value="minor alterations and addition(s)"/>	REASON for SIGNIFICANCE	<input type="text" value="Except for the front porch, this is a well-preserved example of the early Upright and Wing vernacular type."/>
STOREFRONT INTEGRITY	<input type="text"/>		
SECONDARY STRUCTURE	<input type="text"/>

Two rear one story frame additions (one garage, one wing, both non-historic); metal security grates on many windows; replacement porch rail (non-historic); replacement metal windows in original openings on 1<sup>st</sup> floor of south facade; rear 2<sup>nd</sup> floor wood porch deck

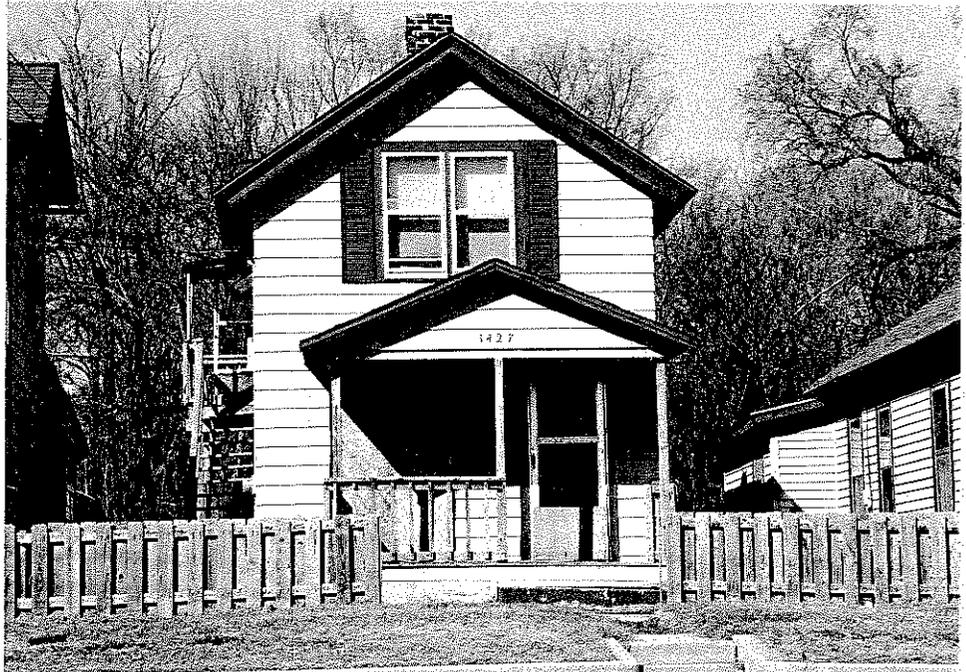
e:\main1427s.jpg

Rear shed roof south and north side dormers [permit #12024 (1947)--raise roof to provide for bedroom]; rear one story shed roof addition; aluminum siding [permit #34305 (1969)--aluminum siding]; boarded up 1st floor windows due to fire; downsized 2nd floor windows in original openings; shutters added; replacement front porch (non-historic); exterior staircase added to south side at rear

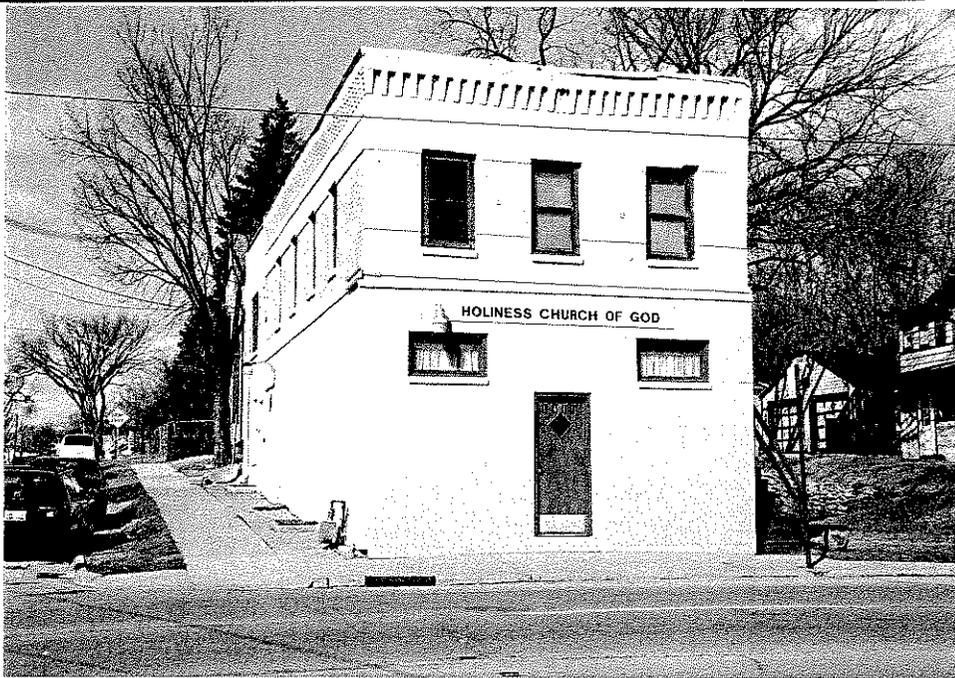
Storefront has been completely altered (includes configuration and materials); brick ?? And single entry door with transom-  
height Aluminum windows [Permit #43658 (1974)-remove glass and brick up, repair stucco as necessary]

Class of Work Remove glass and brick up. - repair stucco as necessary - \$1,000.
