City of ROCKFORD

ILLINOIS URBAN ARCHITECTURAL AND HISTORICAL SURVEY CONTINUATION SHEET

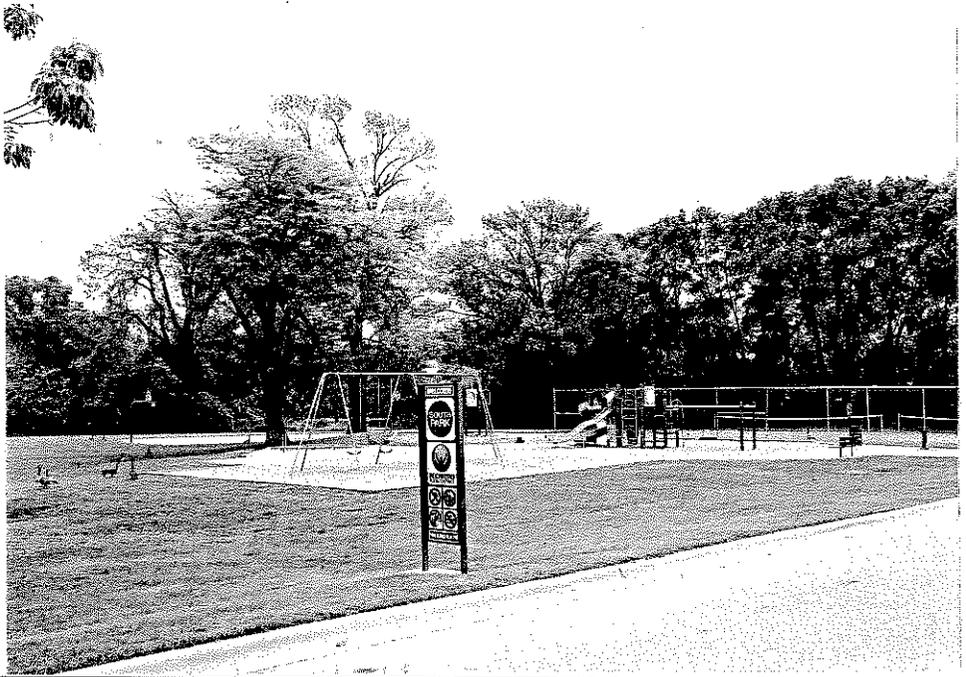
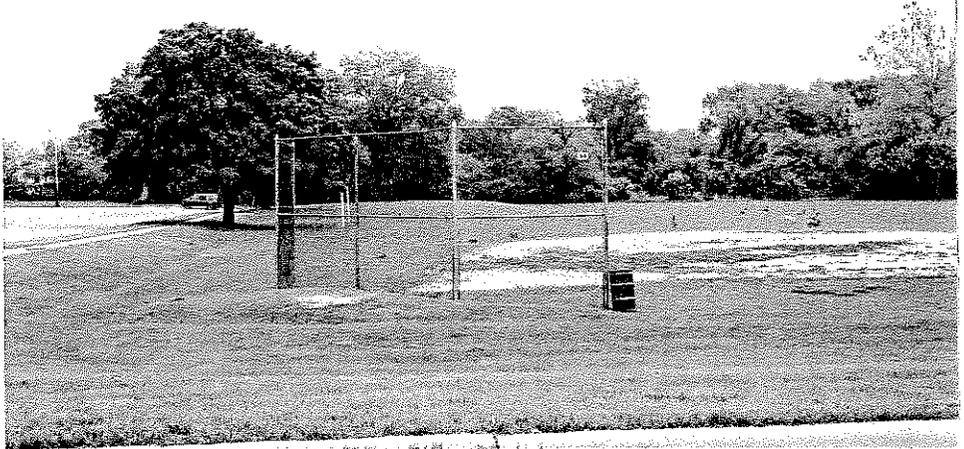
Unmarked baseball diamond with chain link backstop; goalposts; 2 basketball hoops on concrete pad; 2 tennis courts; playground; bordered on east side by river.

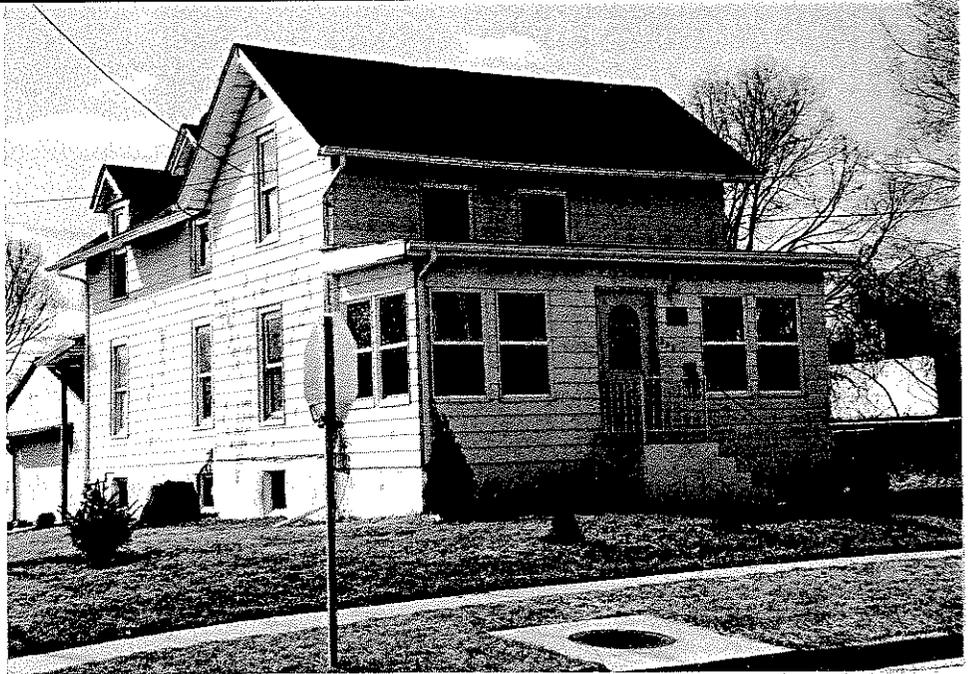
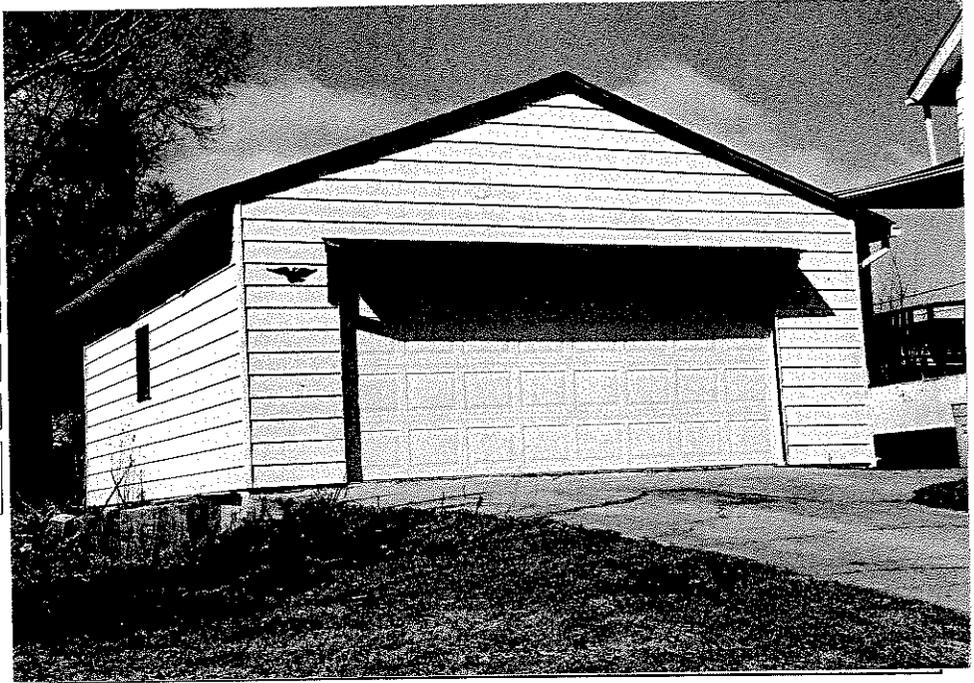
Cement block garage [Permit #3766 (1924)] replaced in 1974 with a 2 car garage [permit #42170 (1974)--2 car garage]

Southwest corner of Rock (100 W) and Lane (400 S); house built on slight rise; chain link fence on west property line; front sidewalk

Aluminum siding; replacement aluminum windows in original openings; enclosed full width front porch (non-historic); Aluminum eaves; 2 story frame historic rear addition (c. 1900) with through-the-cornice dormers; rear porch addition (non-historic); enlarged front windows at 2nd floor on front facade; replacement doors; 7'-6"x22' open rear porch [Permit #14152 (1950)]; repairs to porch [Permit #28672 (1965)]

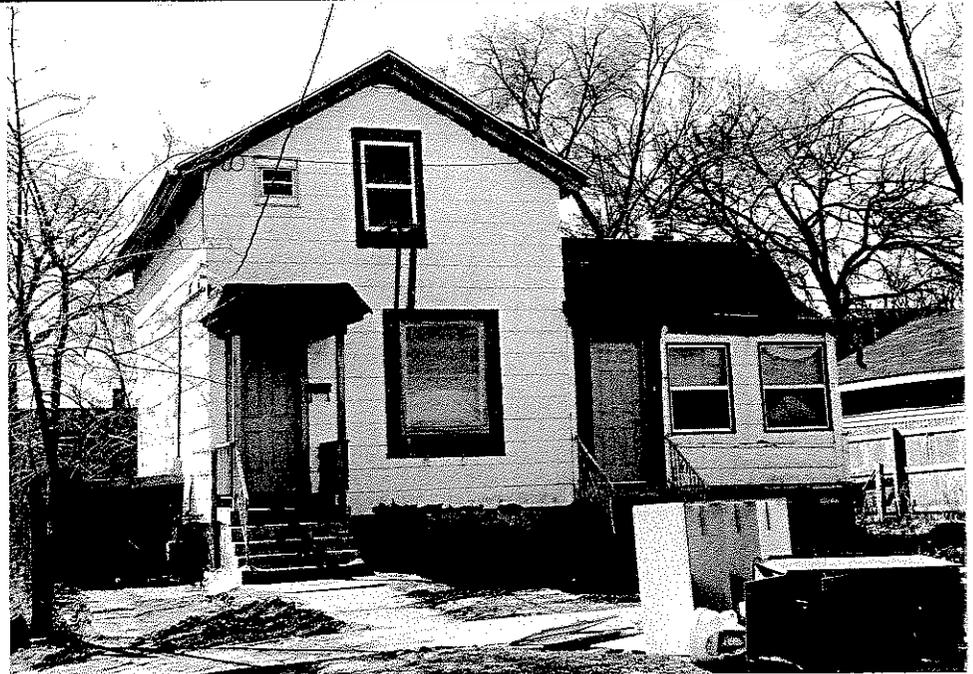
Permit #4829 (1939)--demo shed; Permit #16084 (1953)--cut door in 2nd floor and construct exterior stair

Midblock on mostly vacant residential street; side driveway; house on slight rise; front sidewalk
