ANNUAL REPORT
2011
CITY OF ROCKFORD, ILLINOIS
MUNICIPAL SEPARATE STORM SEWER SYSTEM

NPDES Permit No. ILS000001

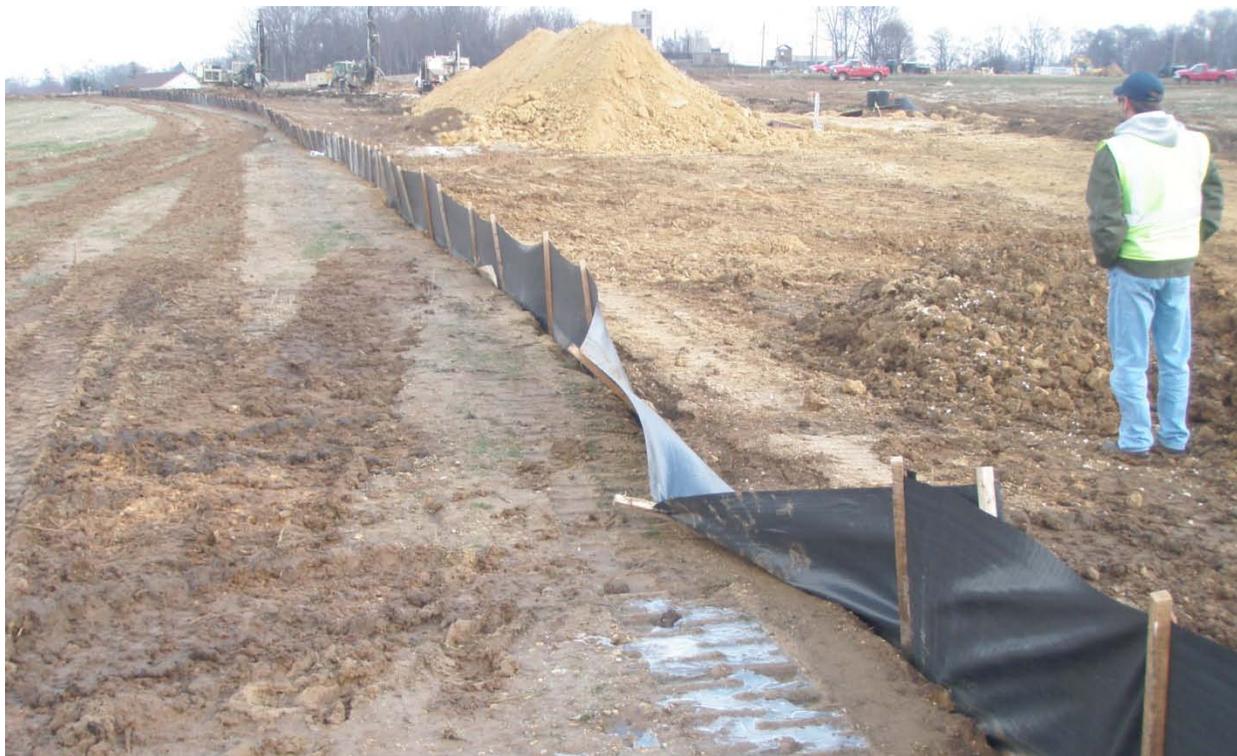
Photograph 1. City staff conducting an inspection in 2011 of erosion control plan implementation.

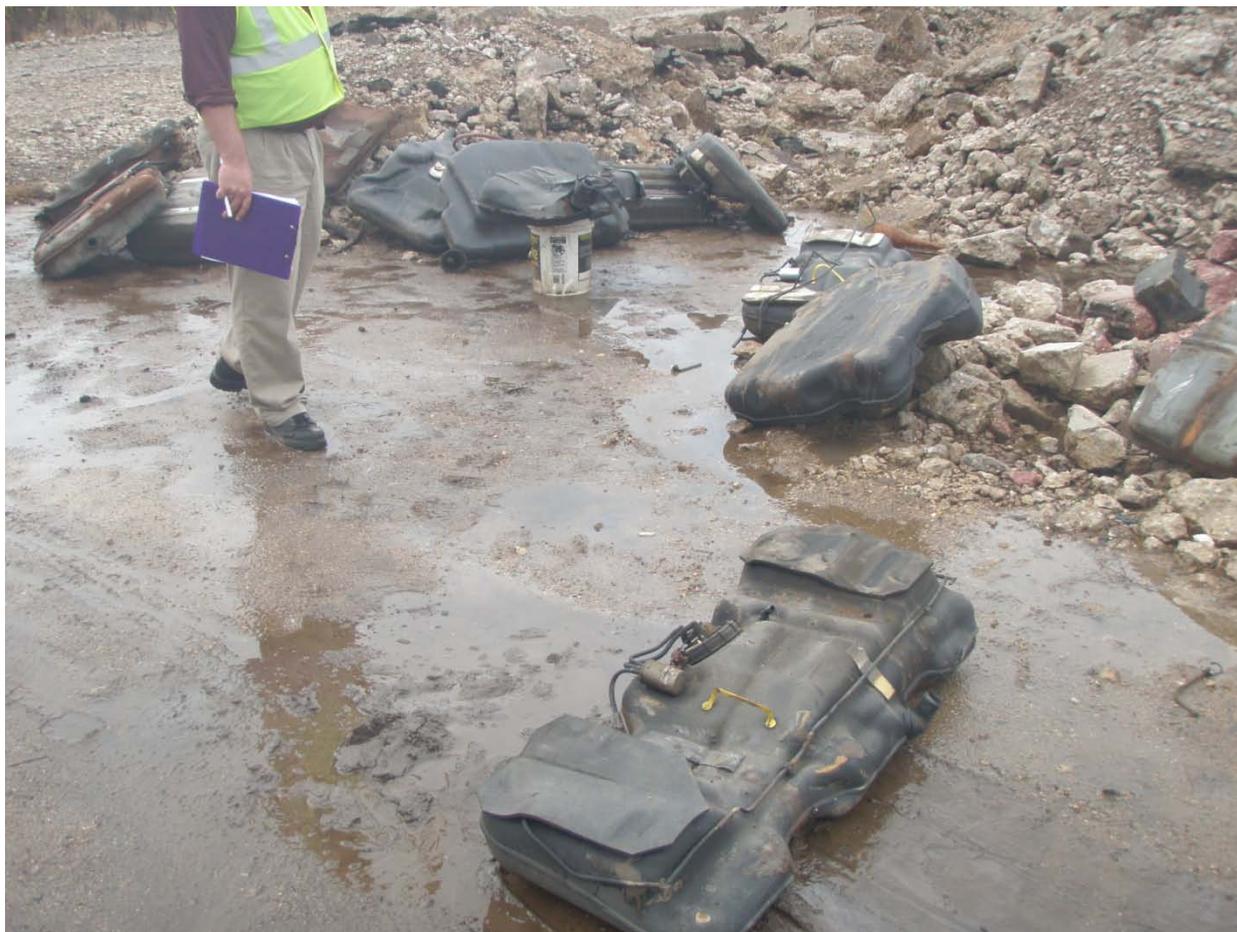
Photograph 2. City Storm Water Inspector during an IHRR field inspection in 2011.

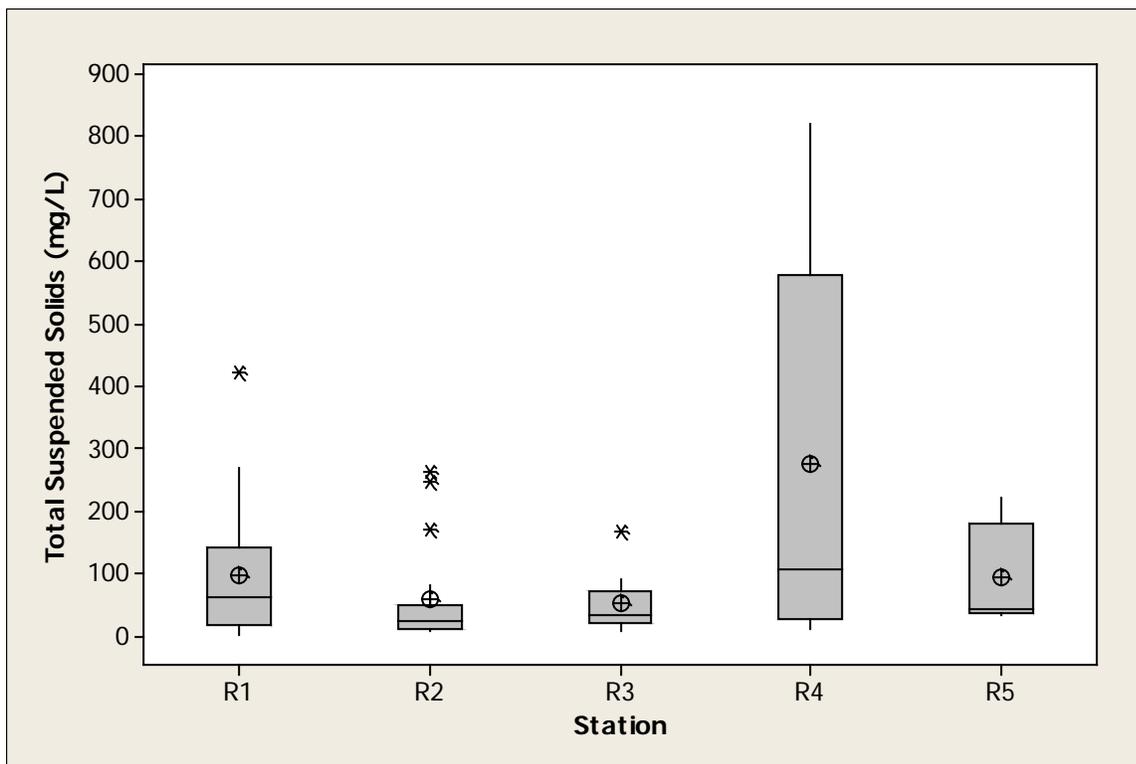
Figure B.1. Boxplot of TSS Concentrations

The boxplot is a convenient method to display medians, quartiles, means, maxima, minima and outliers. Figure B.1 is a boxplot of all total suspended solids (TSS) concentrations observed at the five automated storm sewer stations. The vertical (or interquartile) ranges of the “boxes” reflect the 25th and 75th quartiles of the distribution. The lines, or whiskers, extend upward to the maximum concentration observed at each site and downward to the minimum. The median is shown as a horizontal line within the shaded box; the average is indicated by the circled cross. Potential outliers are shown as asterisks.

Station R3, which reflects the drainage of a 510-acre watershed that is largely residential, has the lowest mean TSS concentration, 51 mg/L. Station R4, reflecting a 780-acre industrial, commercial and residential area had the highest mean TSS concentration, 275 mg/L. A large storage yard adjacent to R4 has been identified as a significant source of TSS and is likely responsible for the high concentrations observed there. This property is identified for inspection under the IHRR Program.

In spite of the occasional high concentrations of TSS at R4, the medians are much closer and ANOVA using the log-transformed concentrations at the five stations indicates that the means are equal, although very near the α level (p -value = 0.058). The grand mean TSS concentration is 115 mg/L and will be used as the event mean concentration (EMC).

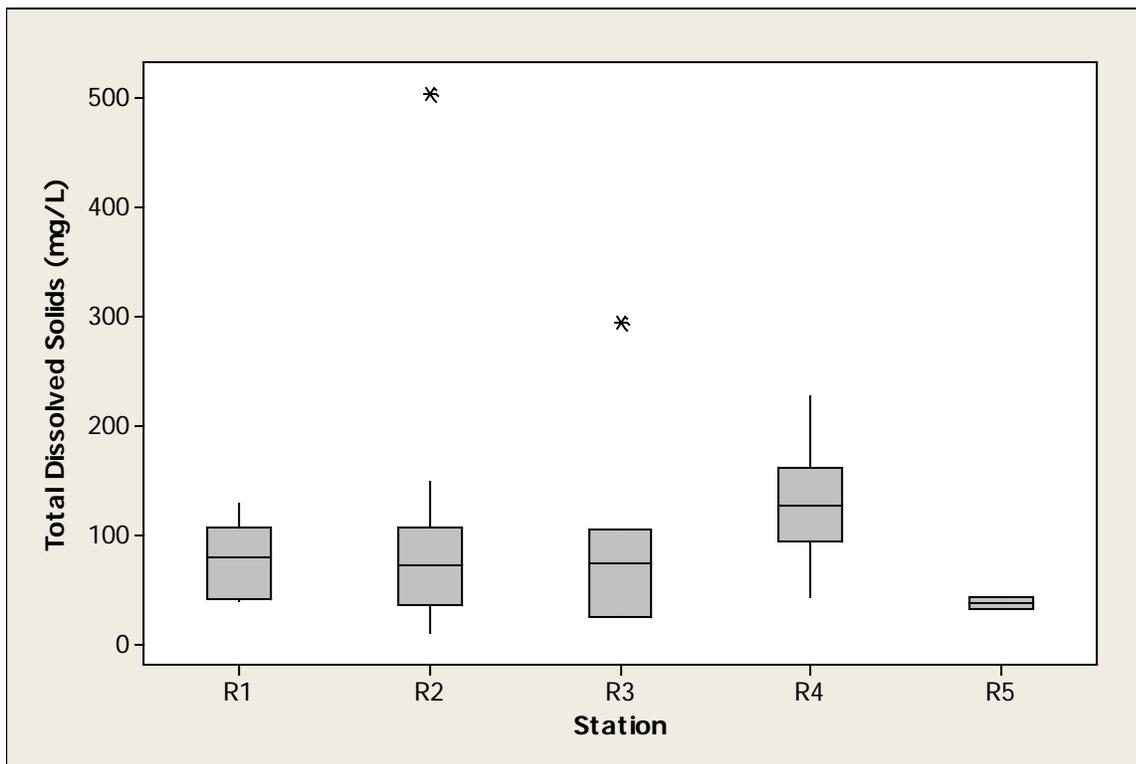
Figure B.2. Boxplot of TDS Concentrations

Total dissolved solids (TDS) in storm water are plotted in Figure B.2. ANOVA indicates that the log-transformed means are statistically the same at all monitoring sites (p-value = 0.101), supporting use of the grand mean, 94 mg/L, for the EMC. None of the samples reflect winter runoff events.

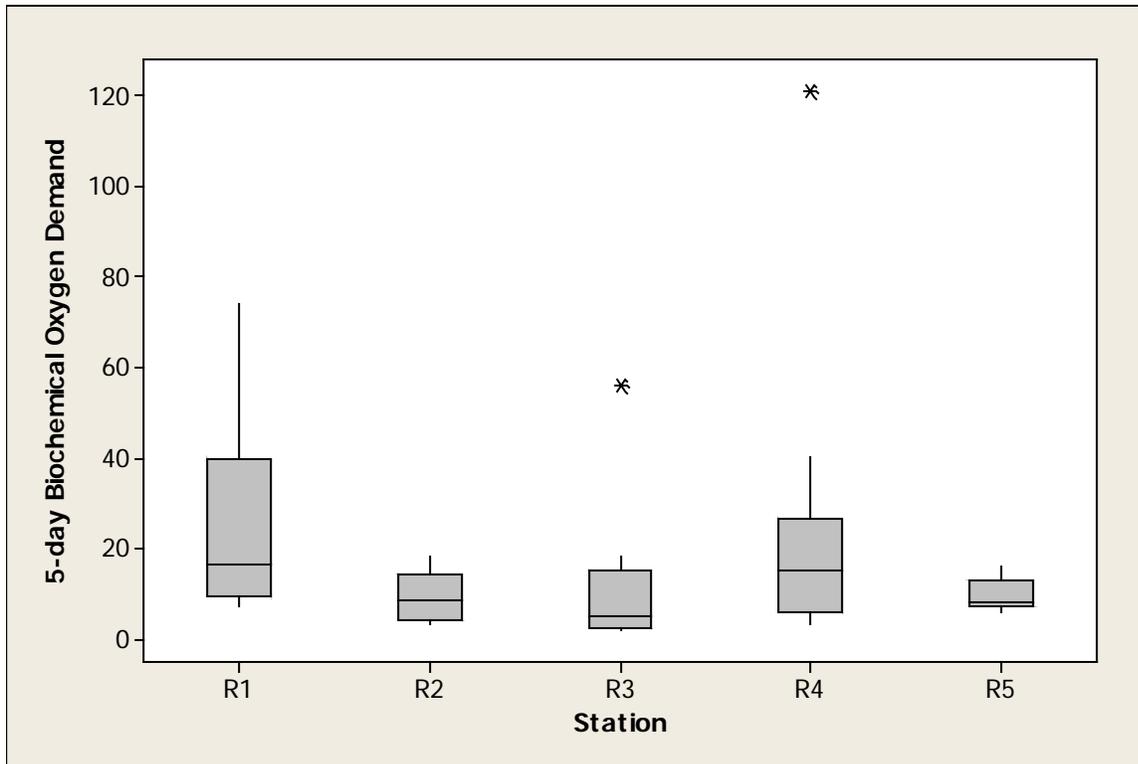
Figure B.3. Boxplot of Biochemical Oxygen Demand Concentrations

The analytical program included 5-day biochemical oxygen demand (BOD) and COD, chemical oxygen demand. Figures B.3 and B.4 illustrate these data, combining data from all prior years of storm water monitoring. ANOVA testing of BOD concentrations found that the station means are equivalent (p=0.120). The grand mean BOD concentration is 16.6 mg/L and is our best estimate of event mean BOD concentration in the Rockford MS4.

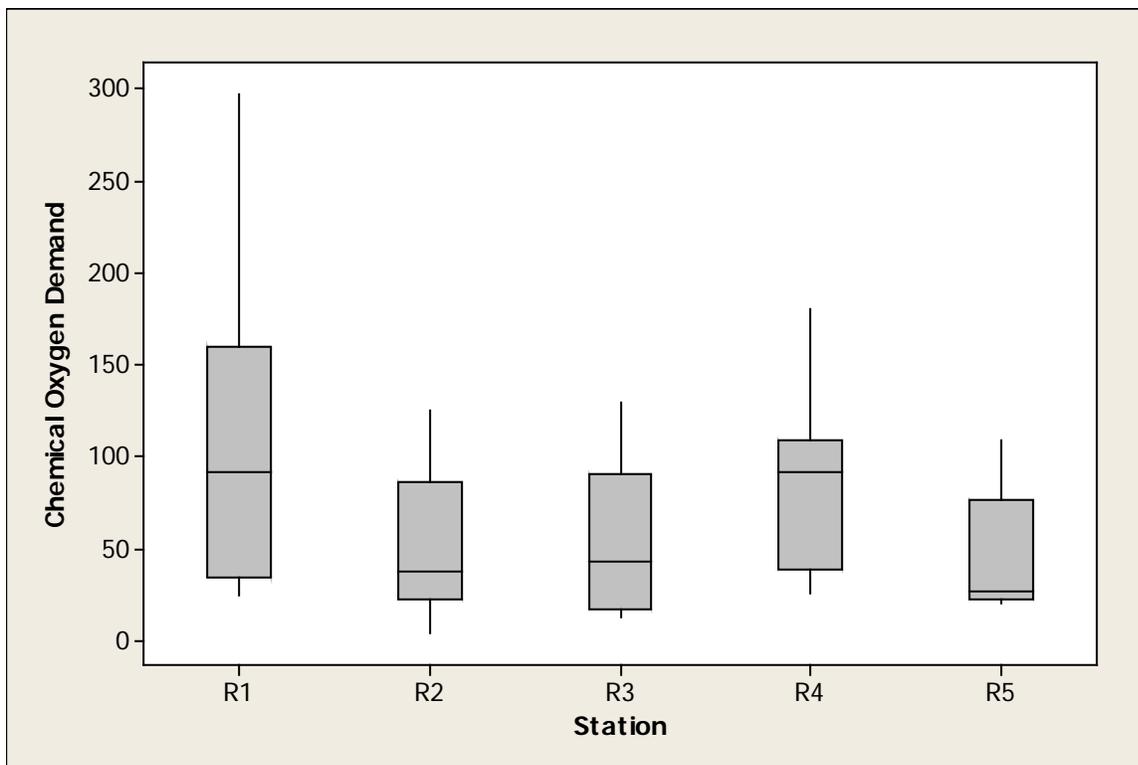
Figure B.4. Boxplot of Chemical Oxygen Demand Concentrations

ANOVA testing of log-transformed COD concentrations found that the station means are borderline equivalent (p=0.050). The grand mean COD is 70 mg/L and is a reasonable estimate of event mean concentration in the Rockford MS4. Individual station means are tabulated below.

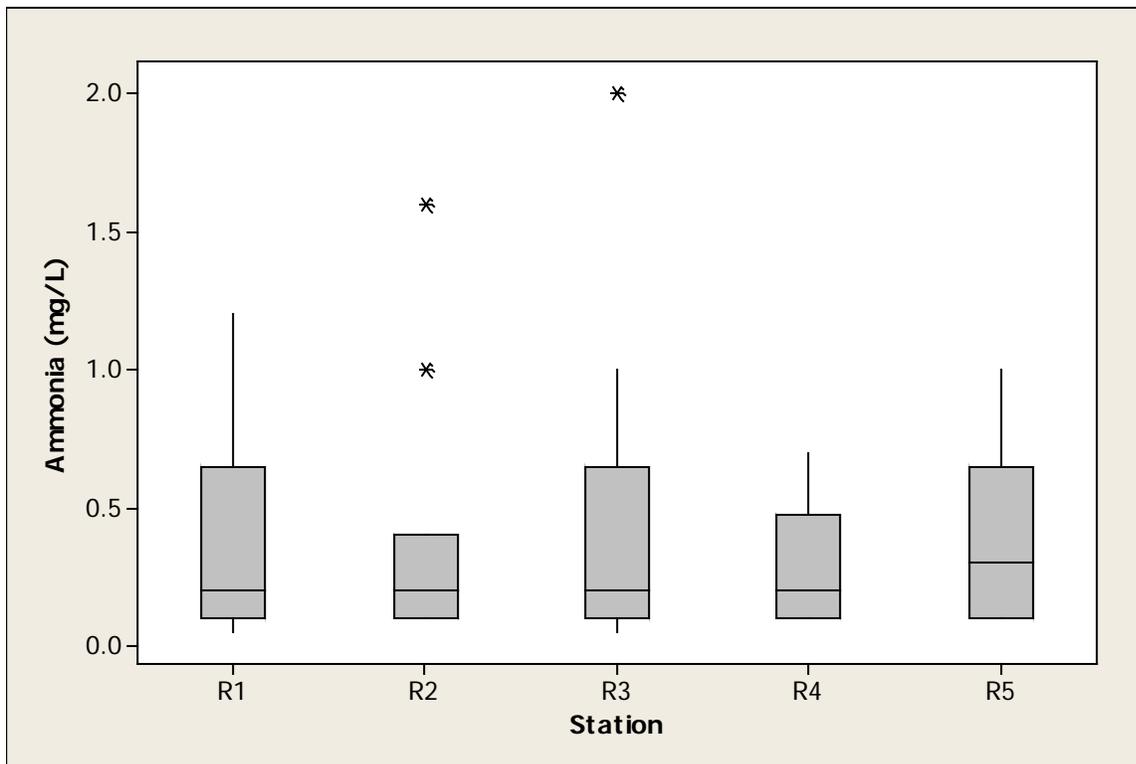
Figure B.5. Boxplot of Ammonia Nitrogen in Storm Water

Ammonia can be an indicator of sewage, so the City continues to utilize this contaminant in assessing potential illicit connections in the MS4. ANOVA using ln-transformed ammonia concentrations indicates that means of the five stations are equal (p-value = 0.959); the grand mean, 0.35 mg/L as N, is therefore the estimate of ammonia EMC.

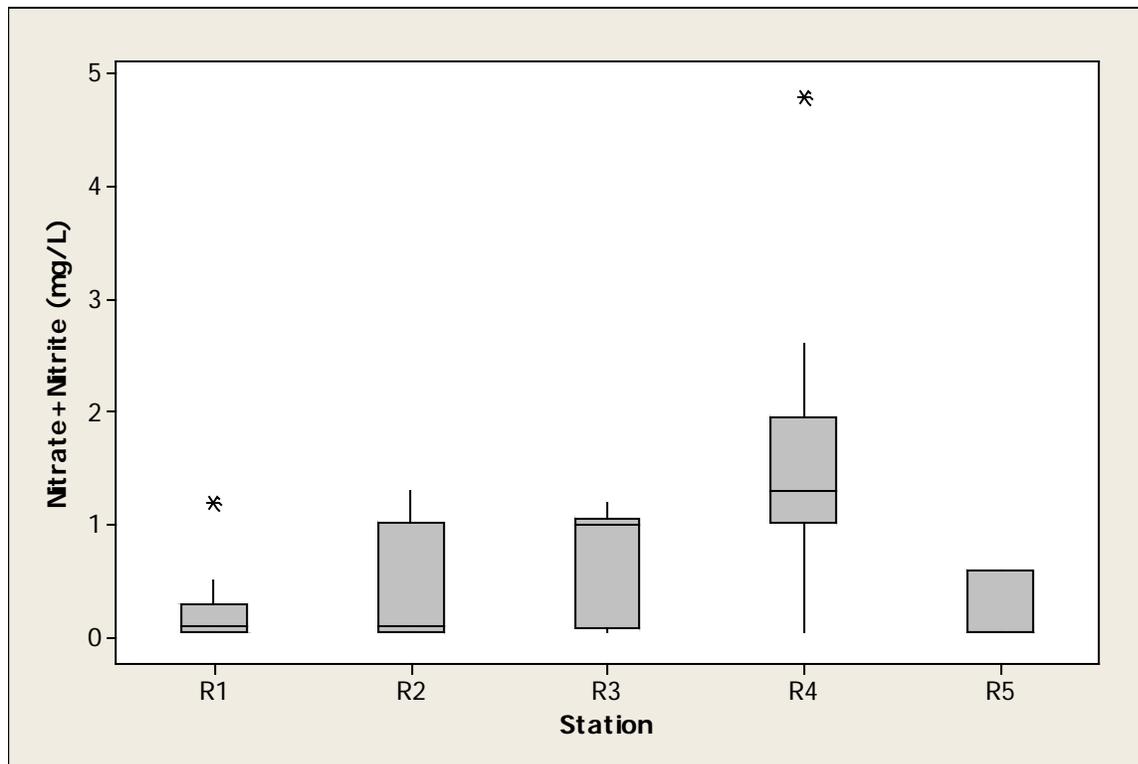
Figure B.6. Boxplot of Nitrate+Nitrite in Storm Water

Table B-3 gives summary statistics for nitrate-nitrite in storm water. Highest concentrations have been observed at R-4, near 8th and Wills Street; nitrate nitrogen concentrations at R4 average 1.6 mg/L. ANOVA and Krustal-Wallis (non-parametric) tests indicate that mean nitrate-nitrite concentrations are not equal among the five stations. Multiple pairwise comparisons indicate that the mean ln-transformed nitrate concentration at R4 is higher than all other stations except R3. The R4 sampling station reflects runoff from a 780-ac mixed-use watershed, including some heavy manufacturing businesses. Lowest concentrations have been observed at R1 and R5.

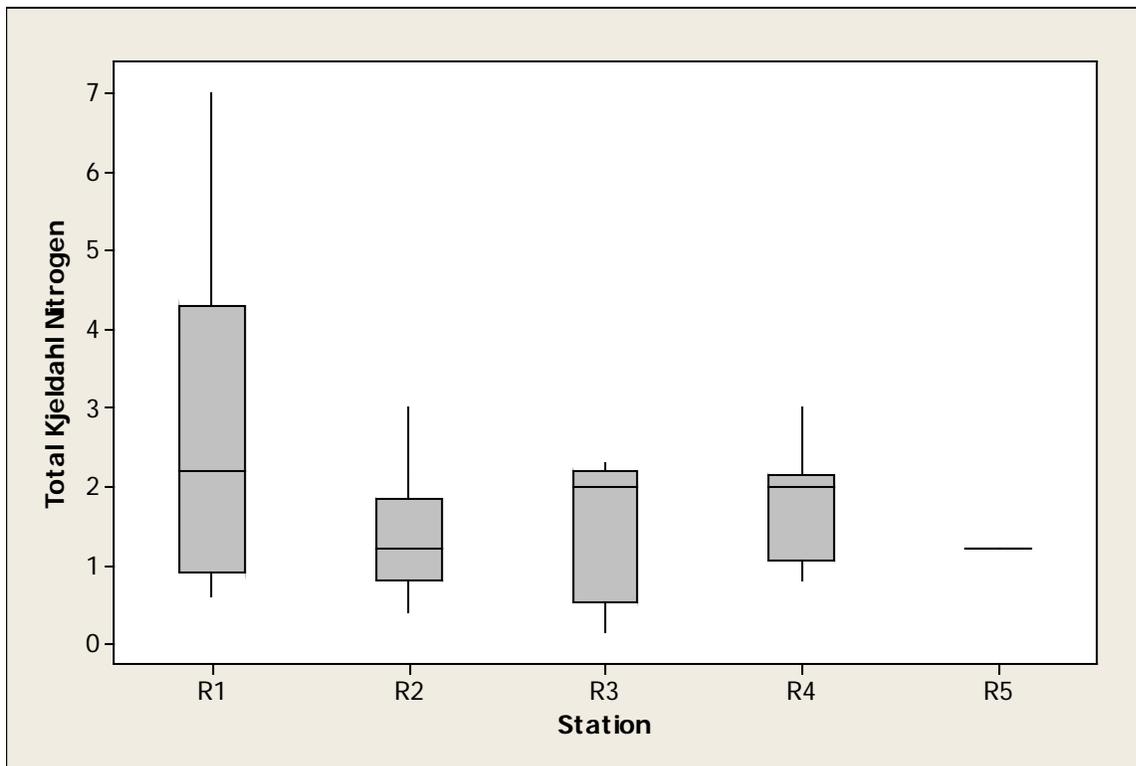
Figure B.7. Boxplot of TKN in Storm Water

Analyses of TKN in the storm water quality database are somewhat more limited, with only 39 measurements. Station R5 has had a single TKN analysis and Station R3 has had five. ANOVA testing using log-transformed values indicates that station means are equivalent (p-value = 0.341). The grand mean TKN concentration will be used as the EMC (1.89 mg/L).

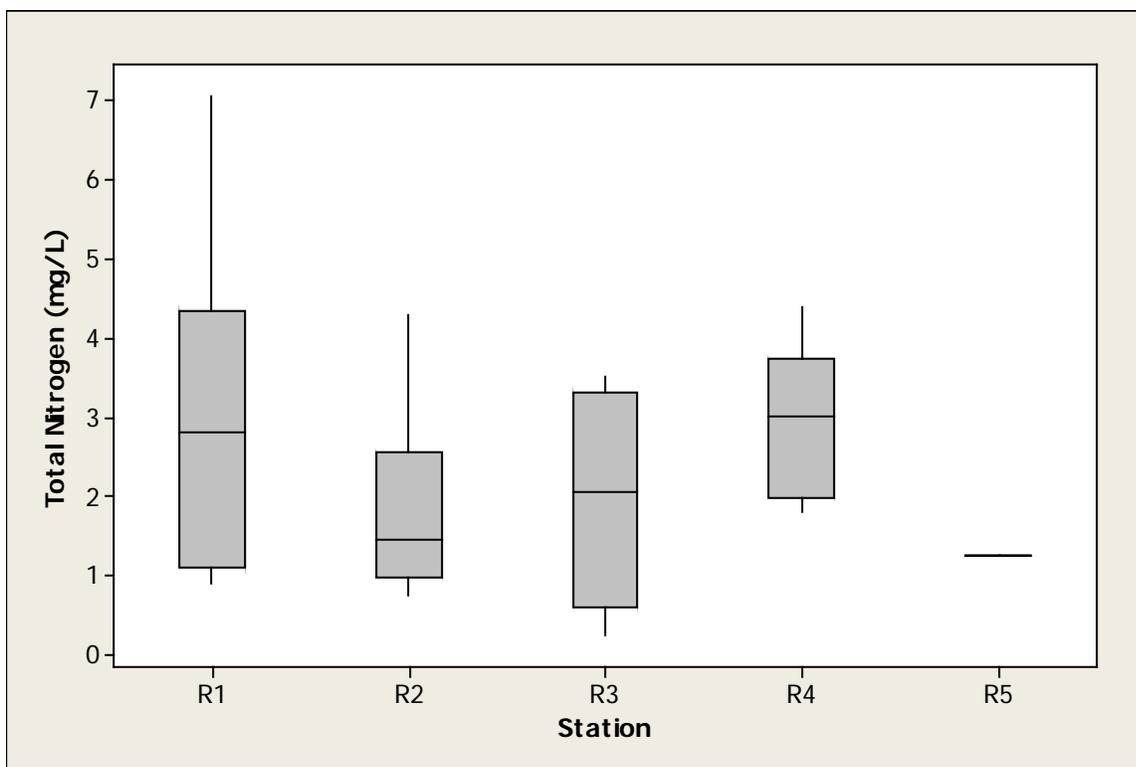
Figure B.8. Boxplot of Total Nitrogen in Storm Water

Mean total nitrogen concentrations (Figure B.8) are not statistically different between the five stations (p-value = 0.253). The grand mean in storm water is 2.46 mg/L and will be used as the EMC for load estimates.

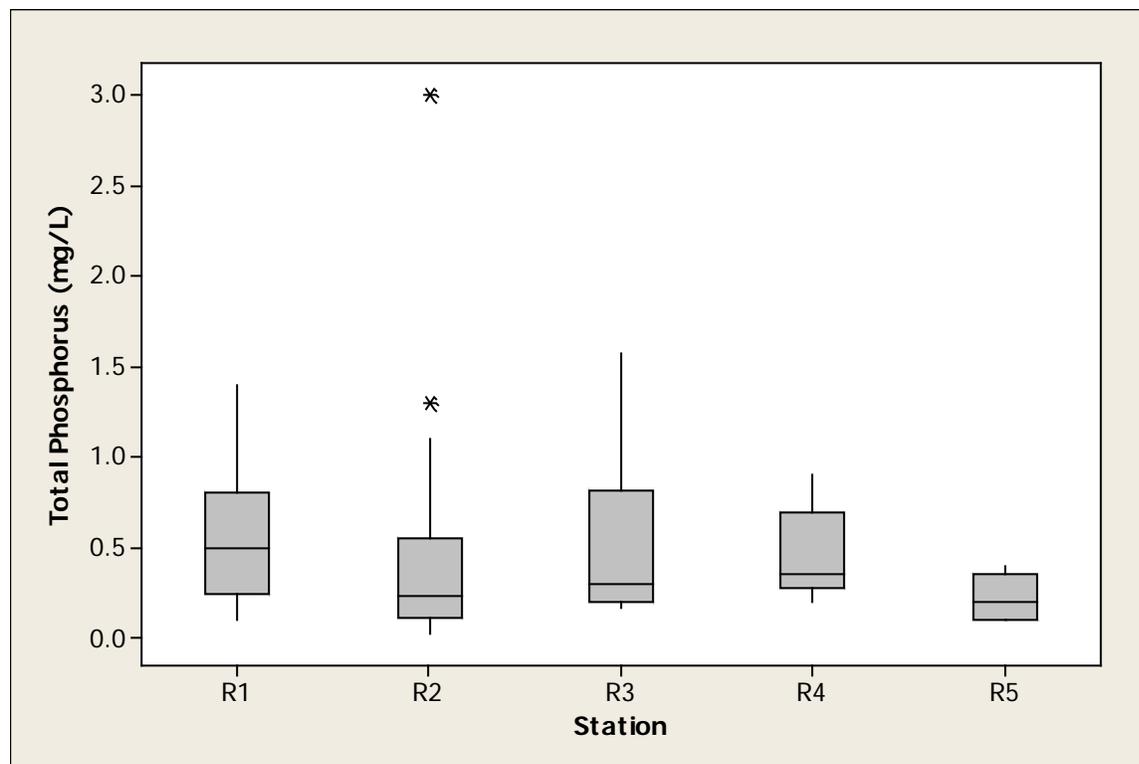
Figure B.9. Boxplot of Phosphorus in Storm Water

ANOVA testing of 52 log-transformed total phosphorus values indicates that they are not statistically different among the five stations (p-value = 0.312). The grand mean phosphorus concentration in storm water is 0.49 mg/L.

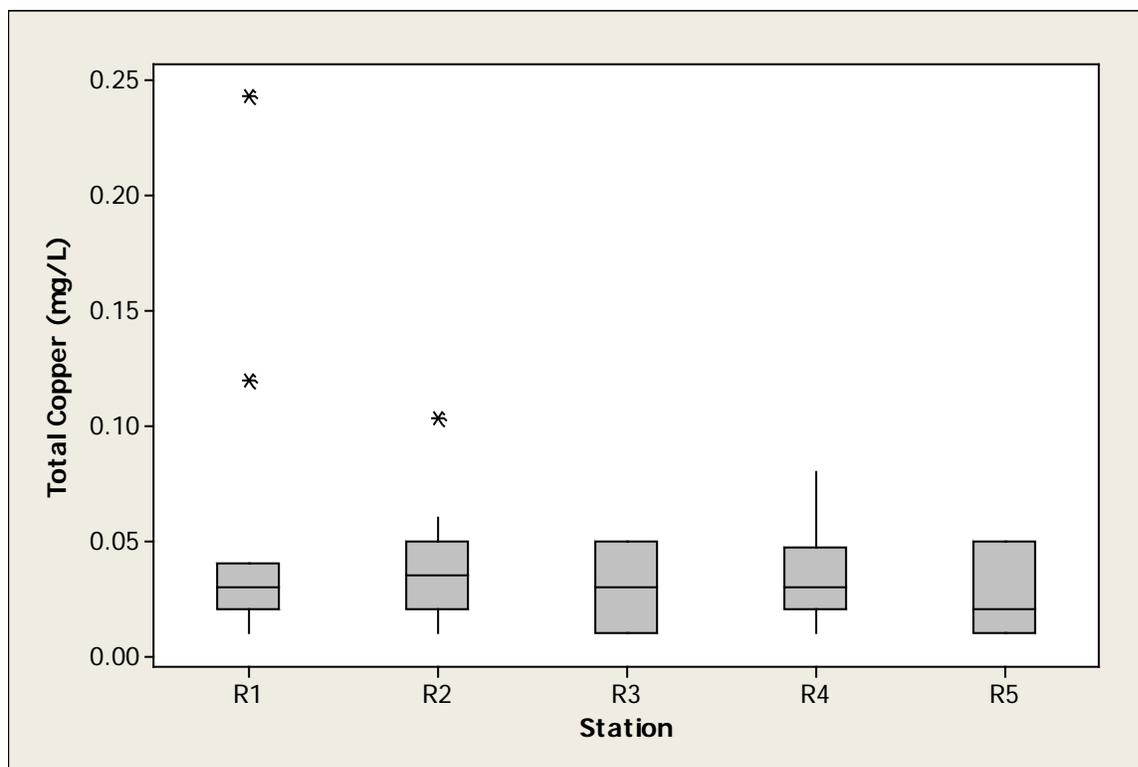
Figure B.9. Boxplot of Copper in Storm Water

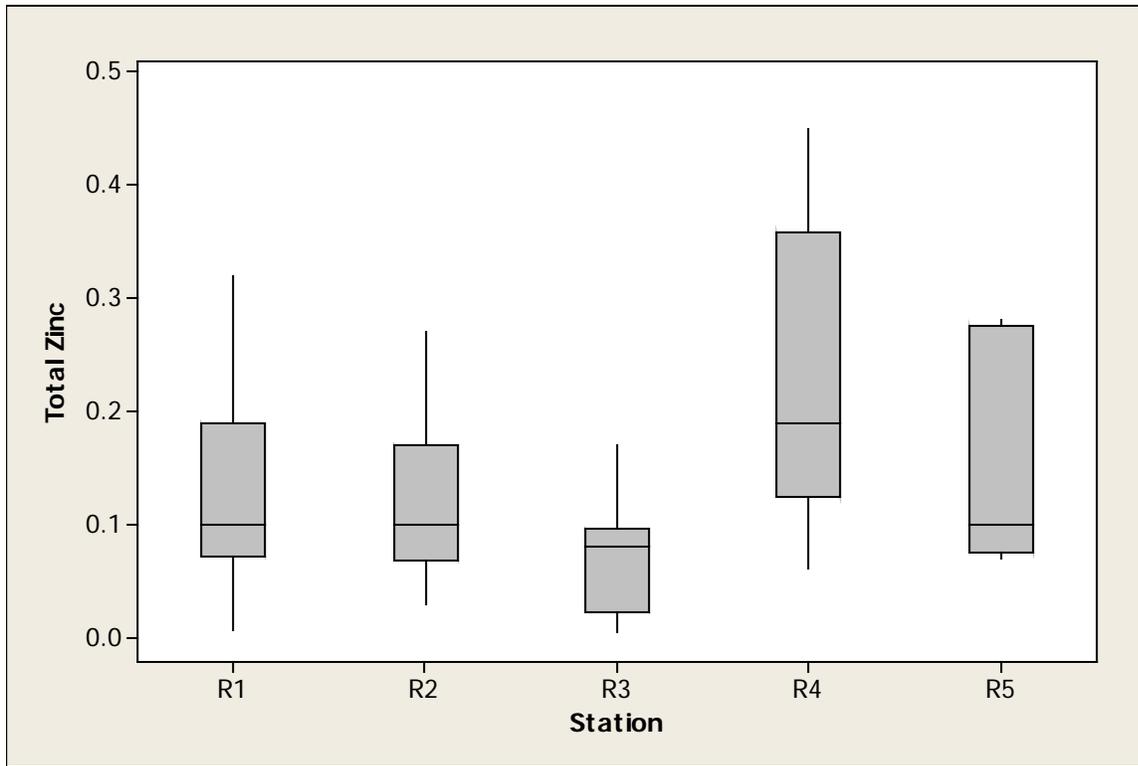
Figure B.10. Boxplot of Zinc in Storm Water

Non-parametric ANOVA testing indicates the zinc concentration medians are not equal among all five stations (p-value = 0.011). Median Zn concentrations measured at R4, near 8th and Wills Street, are the highest of the five stations (0.19 mg/L). The lowest concentrations of Zn have been observed at station R3 (median = 0.080 mg/L).

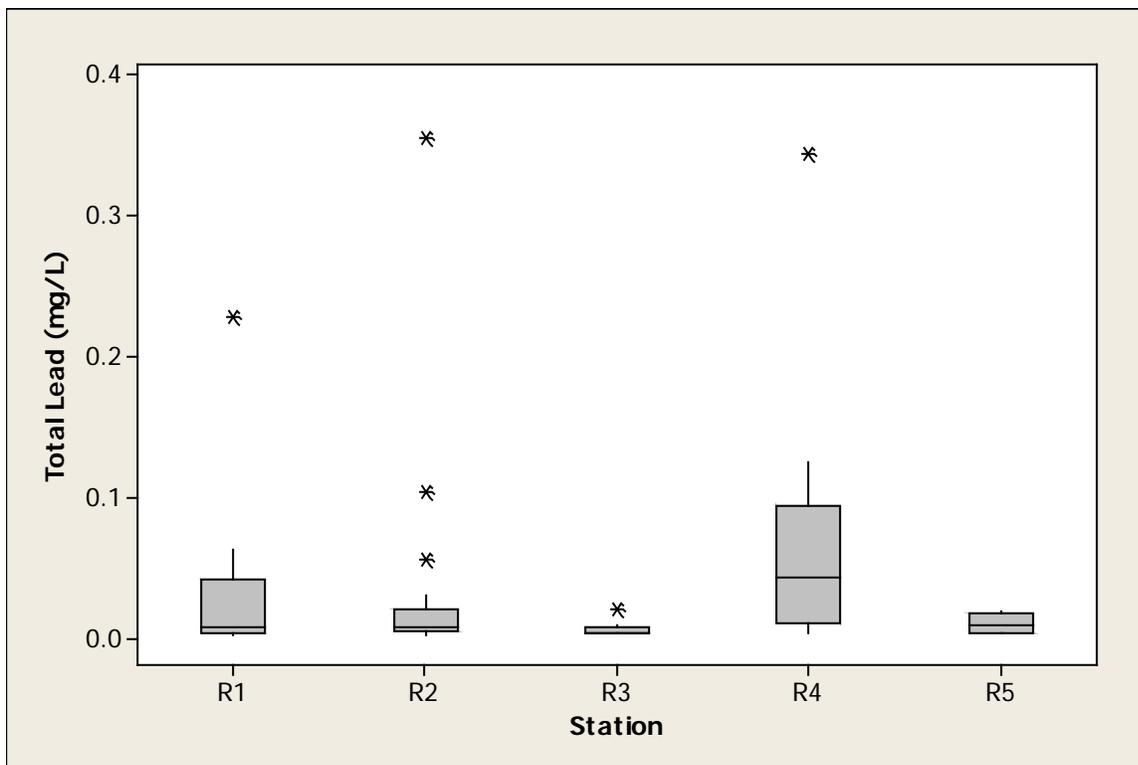
Figure B.11. Boxplot of Lead in Storm Water

ANOVA testing indicates the ln-transformed lead concentration means are not equal among all five stations (p-value=0.025). The lowest concentrations of Pb have been observed at station R3 (0.006 mg/L). And like Zn, the highest concentrations of Pb have been observed at Station R4, near 8th and Wills Street (0.070 mg/L).

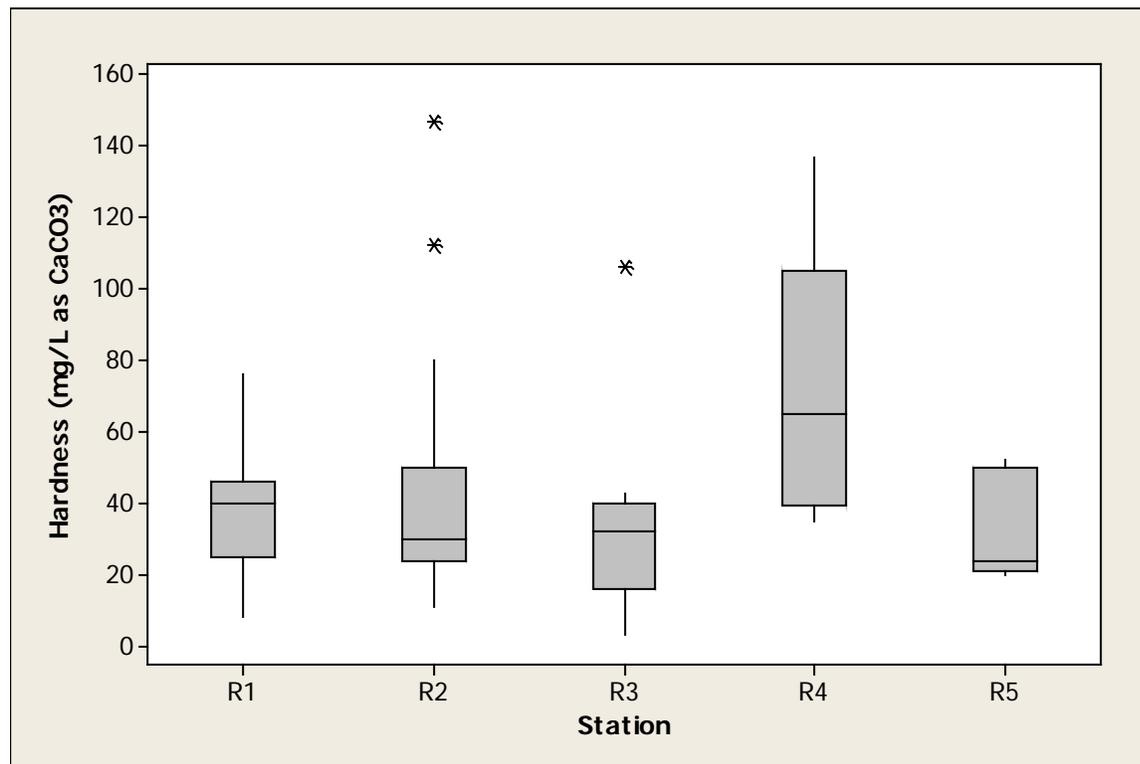
Figure B.12. Boxplot of Hardness in Storm Water

Hardness is routinely analyzed because the toxicities of many metals are hardness-dependent and a hardness value is required to evaluate compliance with surface water quality standards. The other parameters are required by the NPDES Permit. Hardness from measurements in storm water had a grand mean of 46 mg/L. ANOVA indicates that ln-transformed hardness concentrations are not equal between the five sampling stations (p-value = 0.020). Pairwise comparisons indicate that the ln-transformed mean of hardness at R4 is significantly higher than R3; other pairwise comparisons are not significantly different from each other.

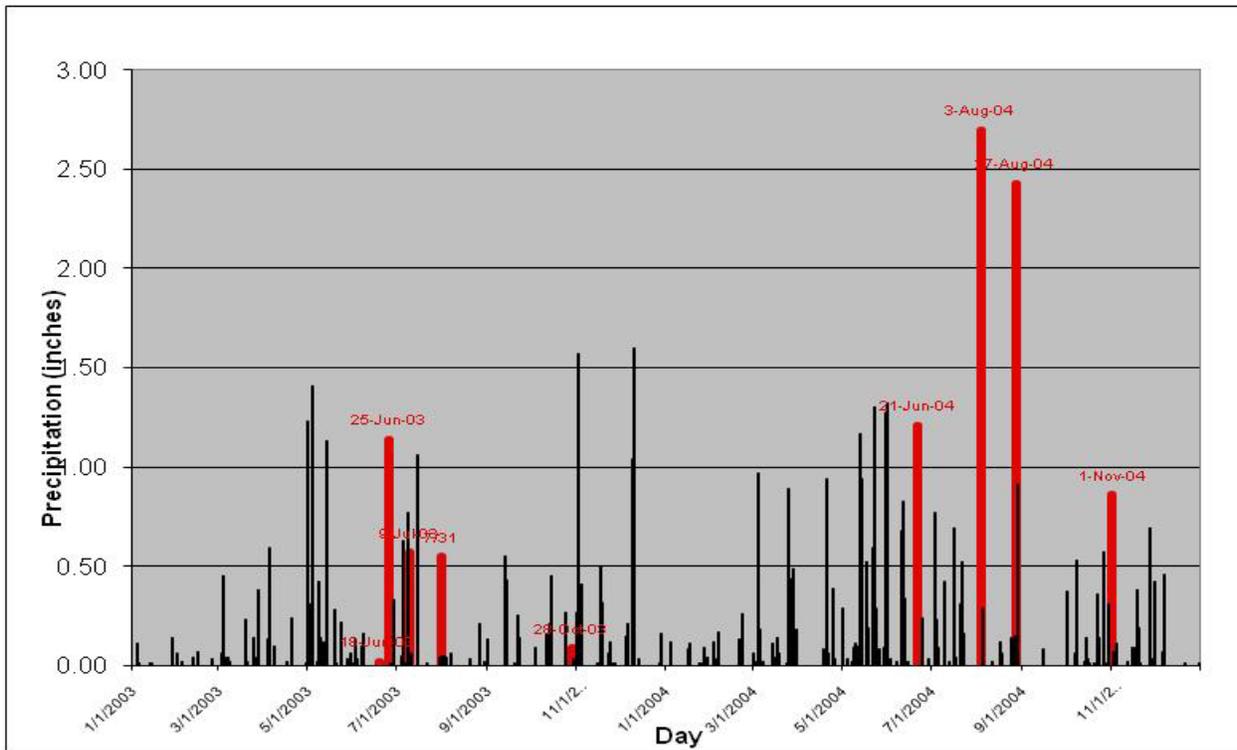
Figure B.13. Daily Precipitation and Sampling Events, 2003-2004

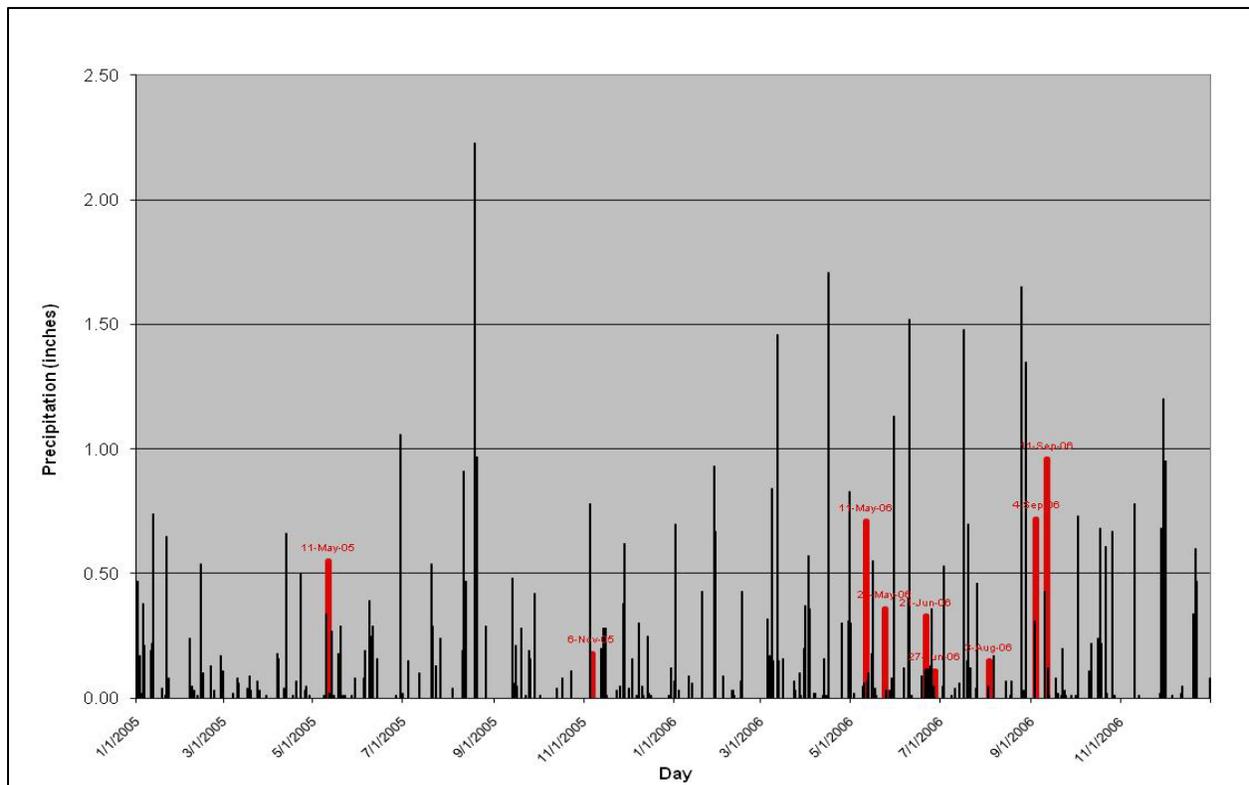
Figure B.14. Daily Precipitation and Sampling Events, 2005-2006

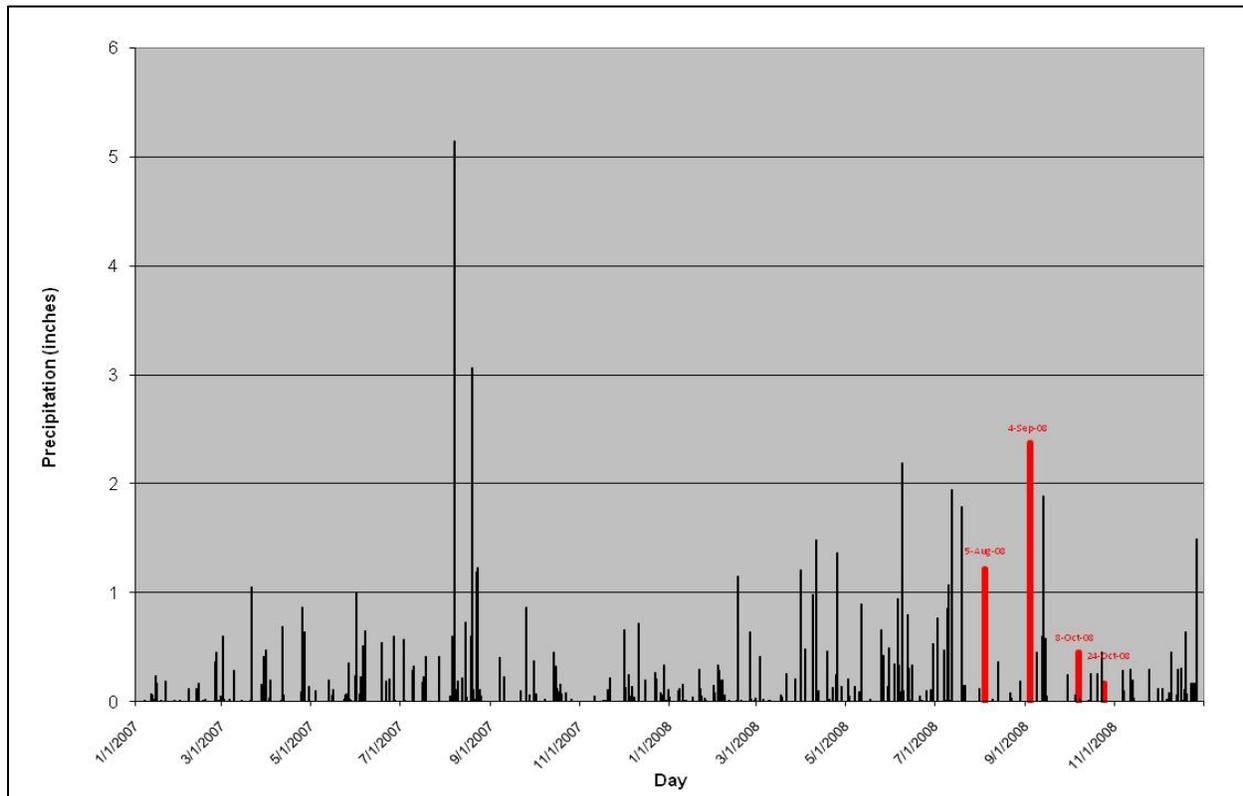
Figure B.15. Daily Precipitation and Sampling Events, 2007-2008

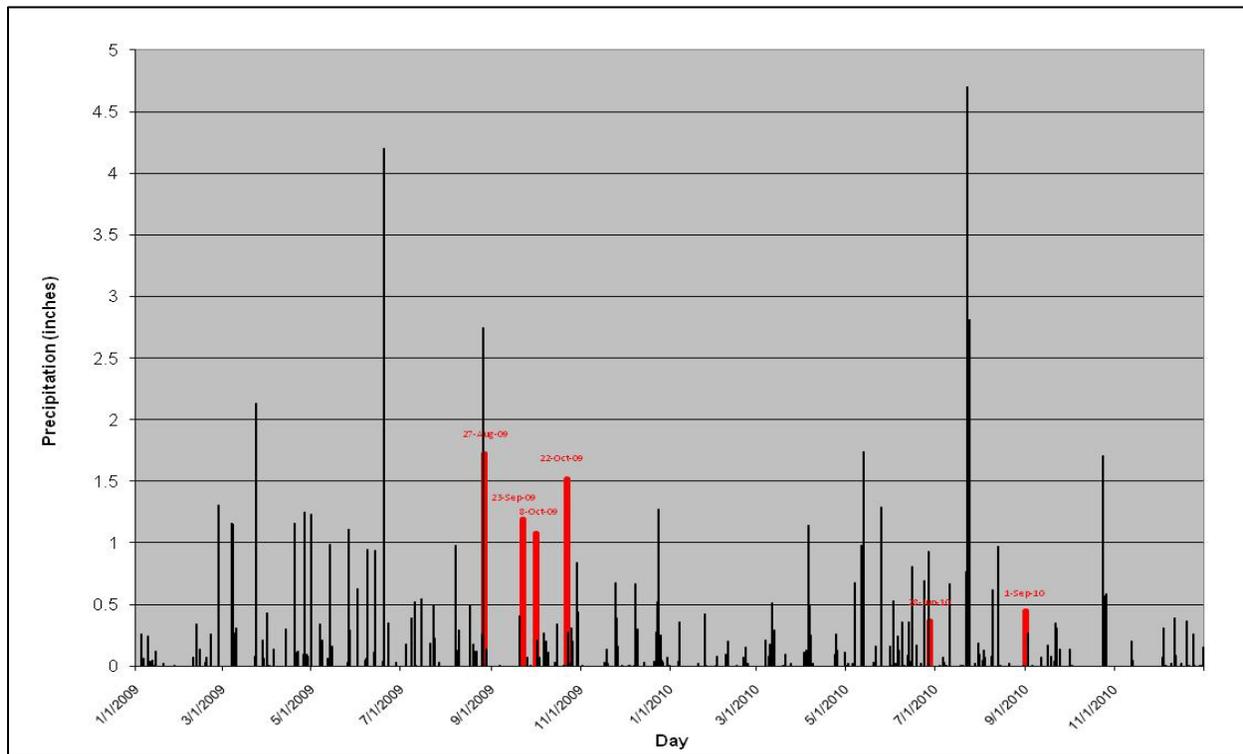
Figure B.16. Daily Precipitation and Sampling Events, 2009-2010

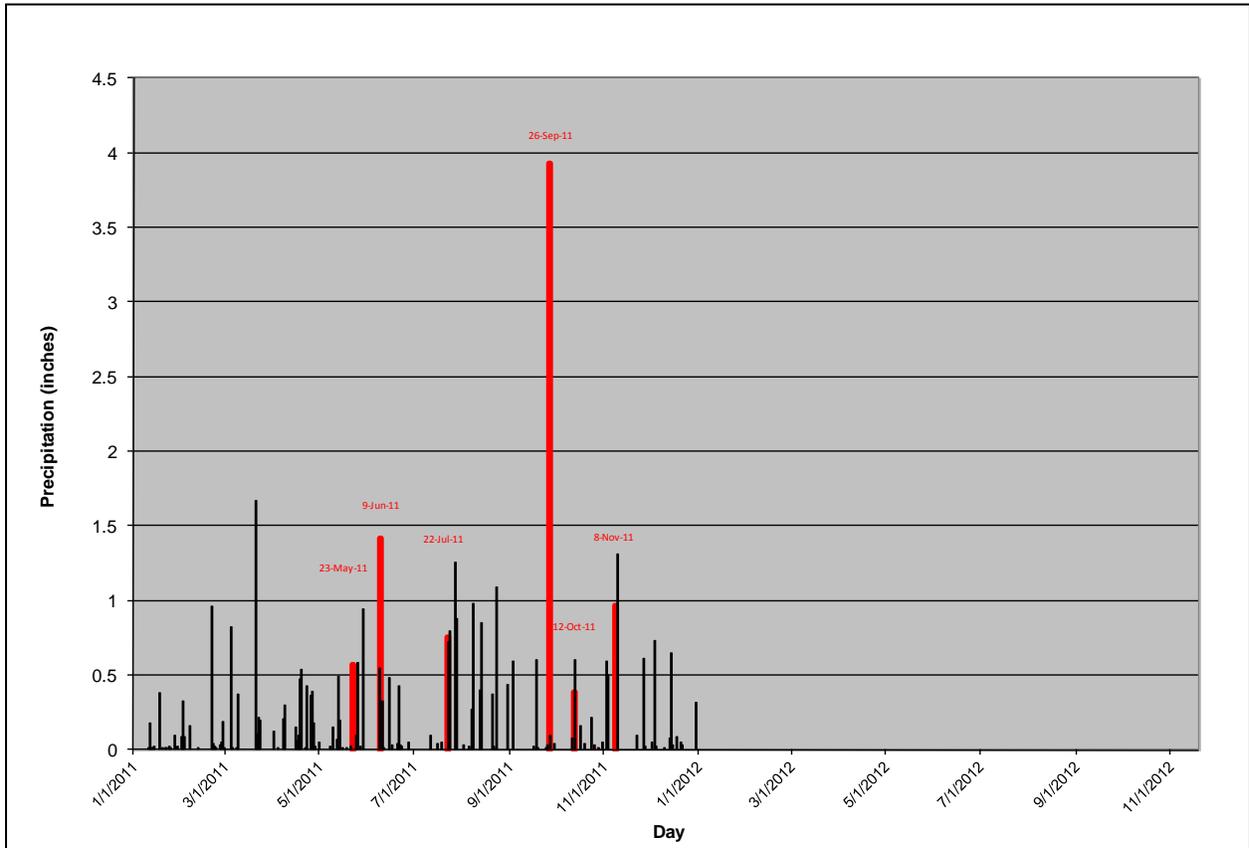
Figure B.17. Daily Precipitation and Sampling Events, 2011

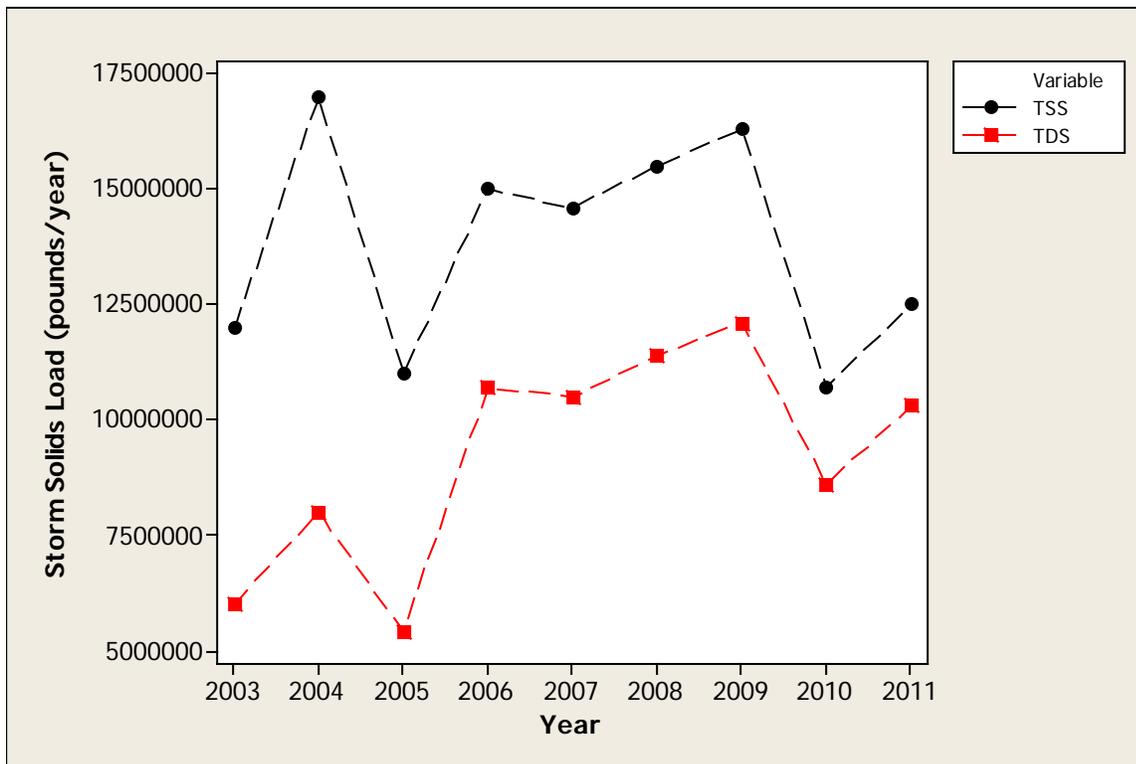
Figure B.18. Annual Solids Loads from Storm Water, 2003-2011

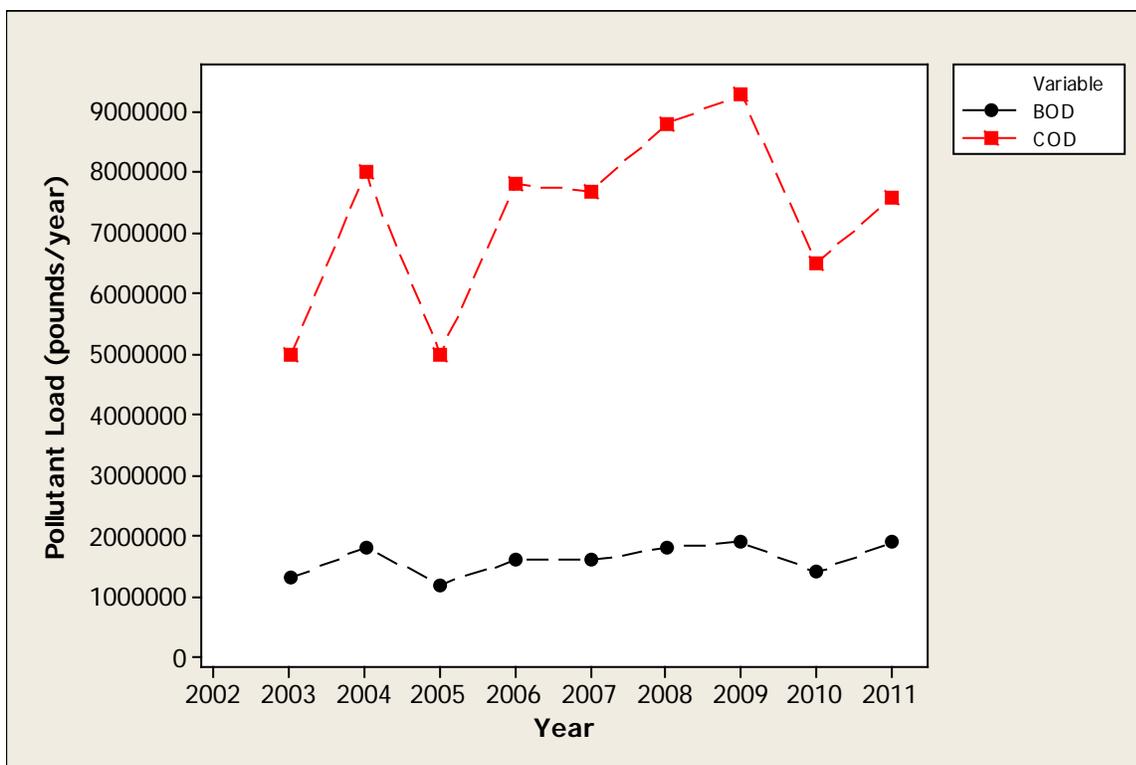
Figure B.19. Annual BOD and COD Loads from Storm Water, 2003-2011

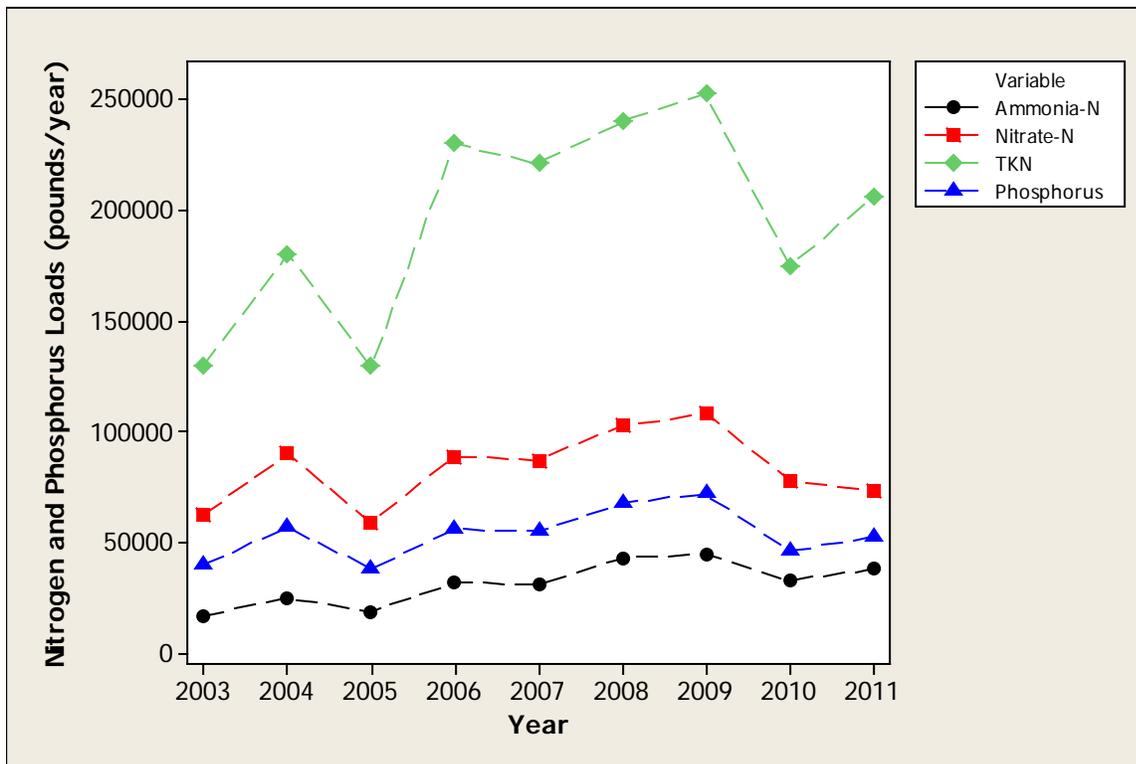
Figure B.20. Annual Nitrogen and Phosphorus Loads from Storm Water, 2003-2010
