ANNUAL REPORT
2011
CITY OF ROCKFORD, ILLINOIS
MUNICIPAL SEPARATE STORM SEWER SYSTEM

NPDES Permit No. ILS000001

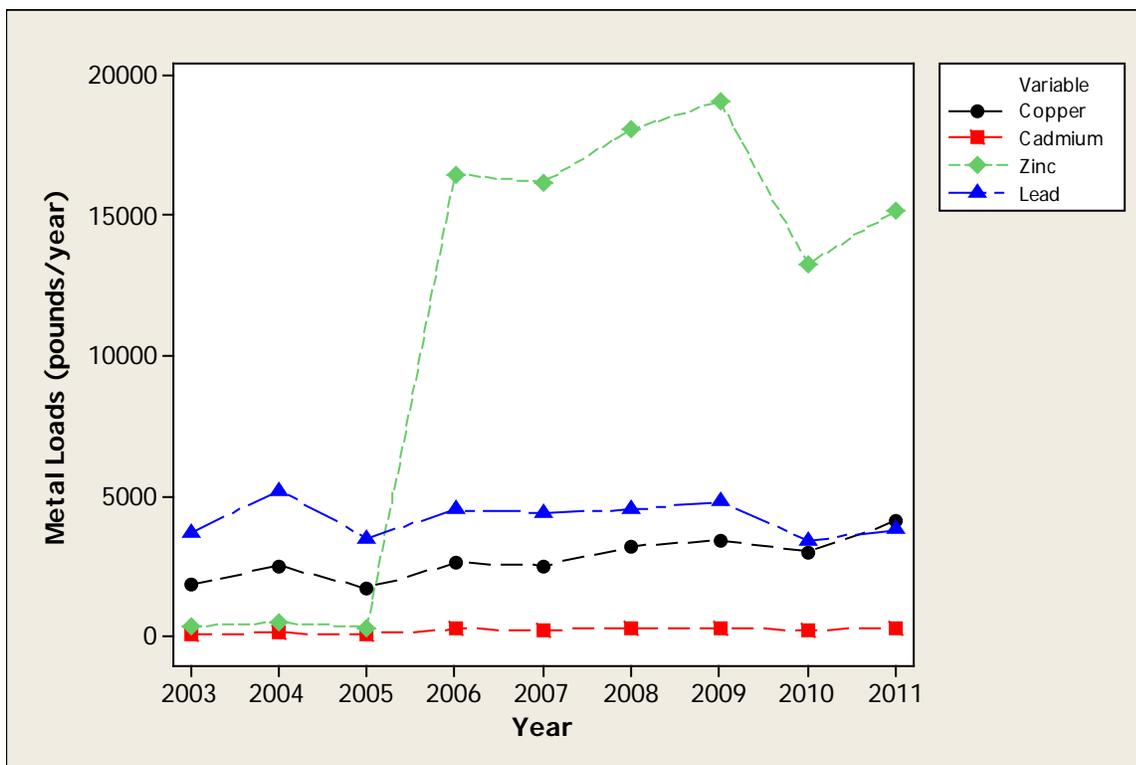
Figure B.21. Annual Loads of Metals from Storm Water, 2003-2010
