City of ROCKFORD

ILLINOIS URBAN ARCHITECTURAL AND HISTORICAL SURVEY CONTINUATION SHEET

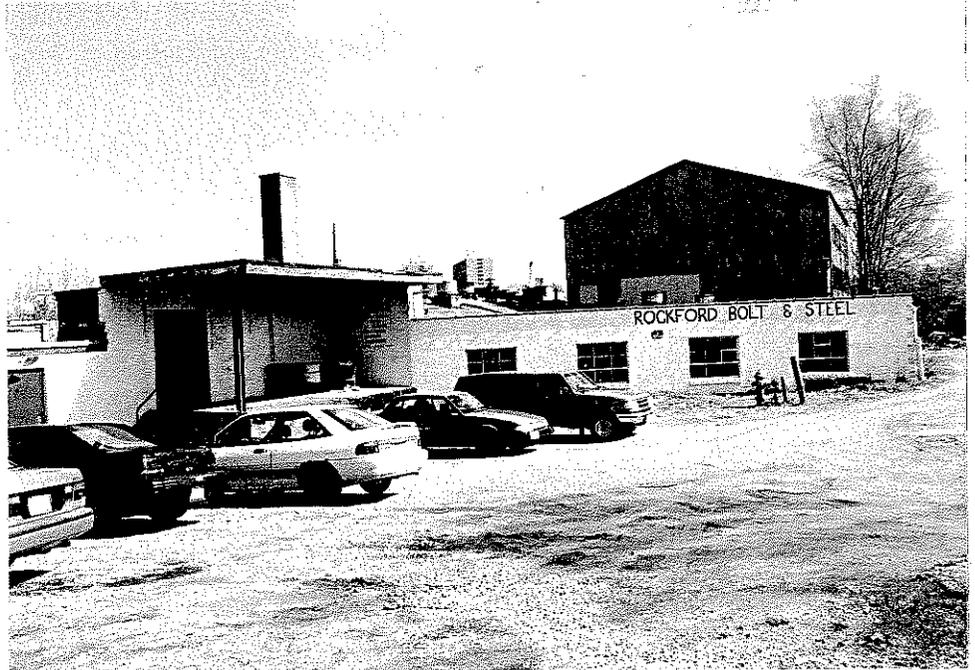
According to a 1950s Sanborn Insurance Map, Rockford Steel and Bolt Company had its Steel Storage, Raw Steel Storage, Storage of Iron Bars and Forge Shop in this building.

At the corner of Kent and Rock, just north of the railroad tracks, Kent Creek runs behind (northerly) buildings

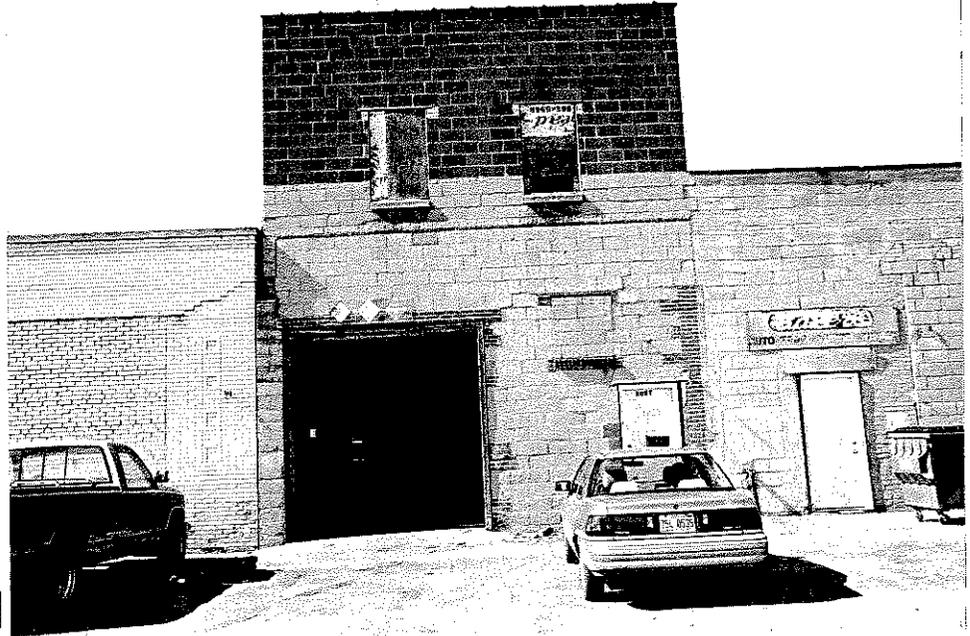
Concrete block in window openings; brick infill; changed garage door openings; interior partitions [permit #21202 (1959)]; see continuation sheet for more permits

At north end of Rock Street; east (front) façade with no setback; no sidewalk, curb

Permits listed for 203 Morgan but are now 1025 Rock: (1940)–1 story rear addition (10x19); #10927 (1945)–one story cement block addition (40x70) to enlarge garage storage; #11032 (1946)–one story cement block addition to warehouse (36x75)

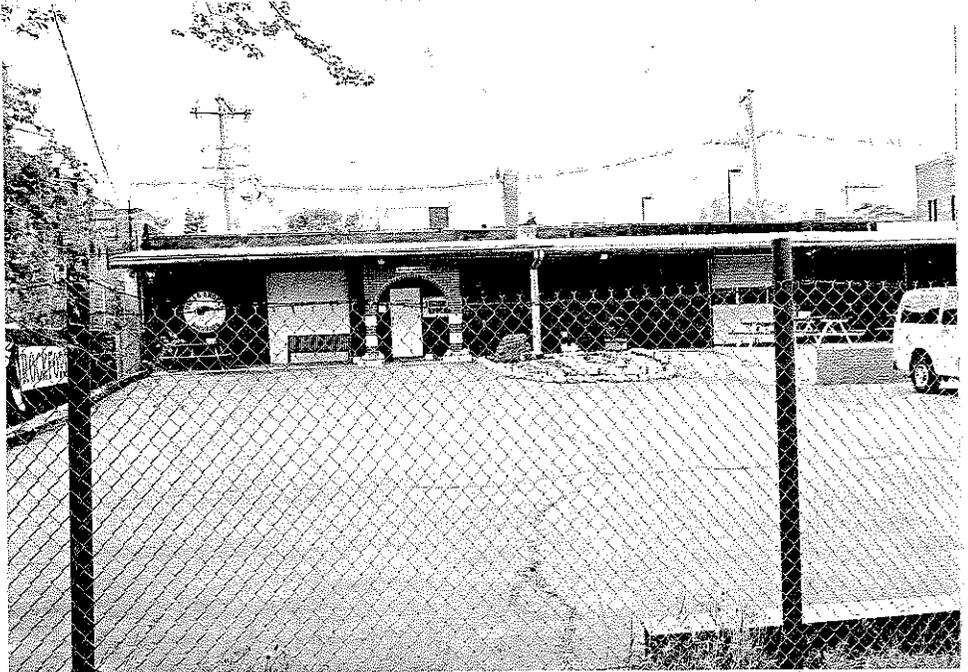
Midblock on west side of street;
asphalt parking lot and chain link
fence at front

All openings have been enclosed with block or bricked in, except for a garage door on front façade (replacement overhead door) and current entry (replacement door); full width metal canopy and platform added across front façade with concrete block [#11182 (1946)--concrete loading platform and #7805 (1940)--24x35 platform]; #19854 (1958)--remodeling (\$3000); B81-762 (1981)--1 story south side addition (66x31)

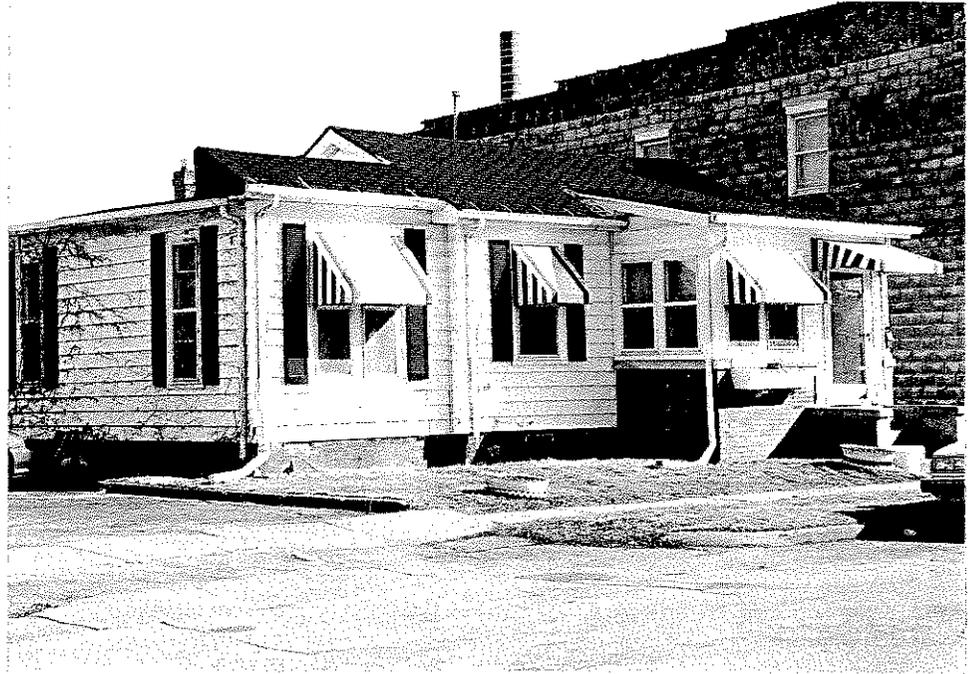
Additional permits -- #374 (1920)--reshingle house; #4510 (1930)--addition to warehouse(?); #9845 (1943)--enclose space between buildings for a garage; #10248 (1944)--insul-brick siding

Midblock on east side of street; front sidewalk; grassy lawn and parking

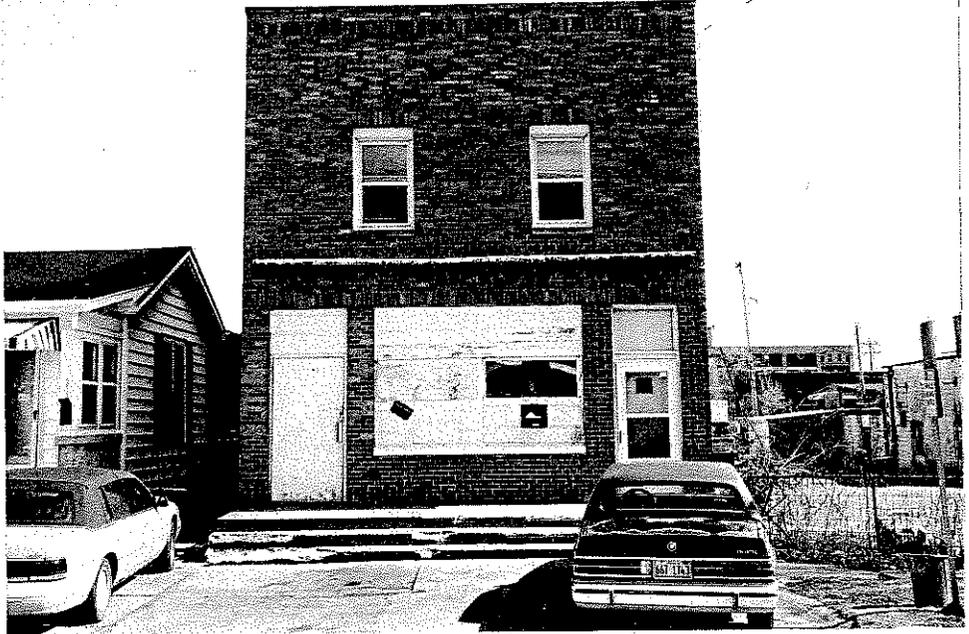
One storefront with side entry and one display window; entry to 2nd floor at side

Boarded display window & boarded transoms above doors replacement doors in original openings

Midblock on east side of street;
parking in parkway; no setback;
mixed uses on street

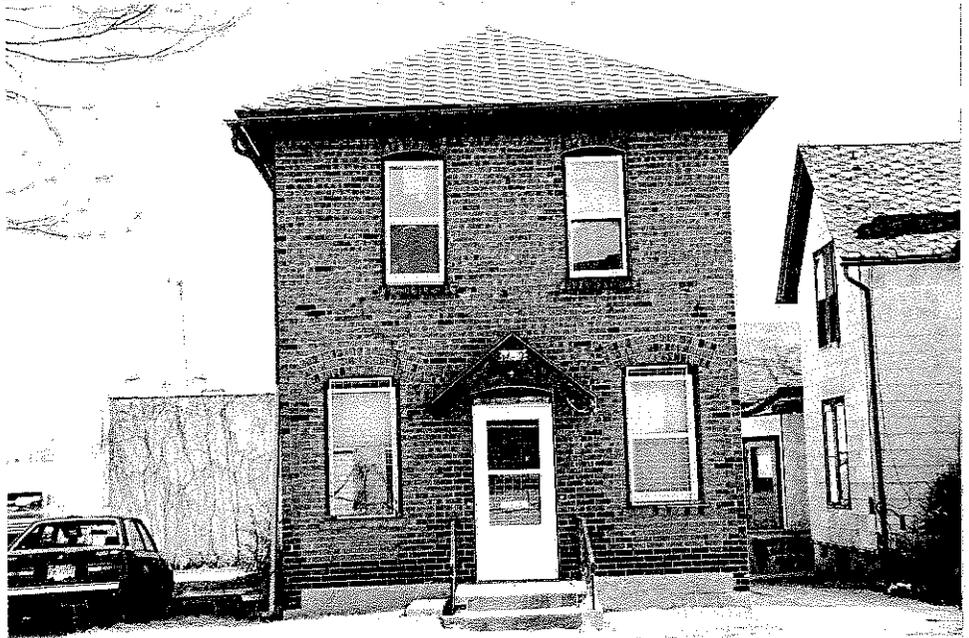
changing 1st floor from store to 1 family apartment; rock lath, plaster partitions [Permit #77408 (1940)]; downsized windows on either side of front door

Midblock on east side of street;
concrete sidewalk and parking; small
grass front and side lawn

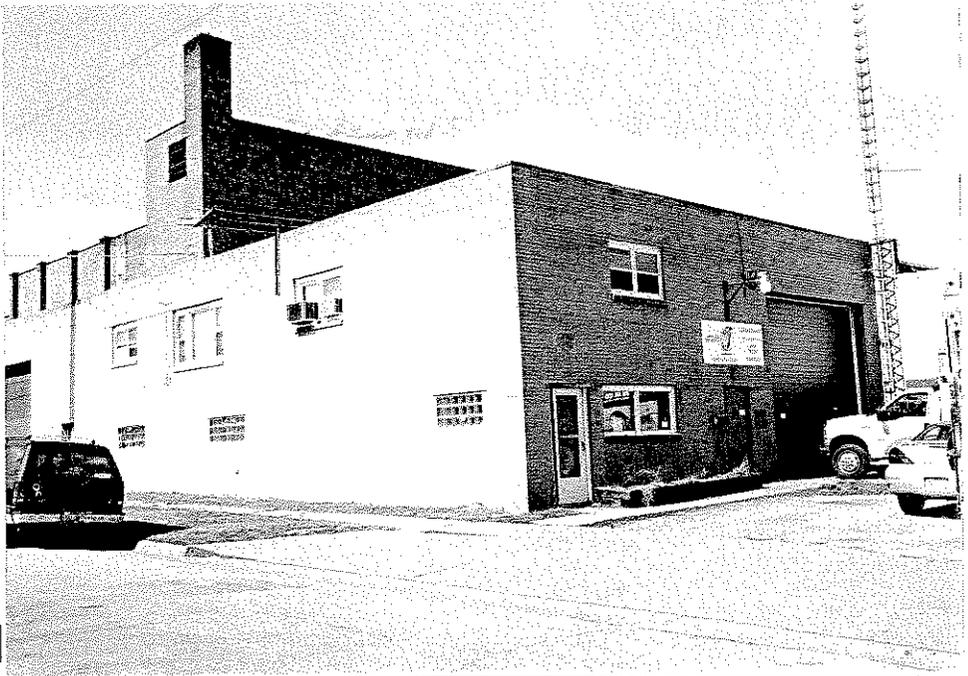
CATEGORY building CURRENT FUNCTION Transportation - road-related (vehicular)
 CONDITION good HISTORIC FUNCTION Transportation - road-related (vehicular)
 INTEGRITY minor alterations and addition(s) REASON for SIGNIFICANCE
 STOREFRONT INTEGRITY
 SECONDARY STRUCTURE

ARCHITECTURAL CLASSIFICATION Garage PLAN rectangular
 DETAILS NO OF STORIES 1
 BEGINYEAR 1965 ROOF TYPE Flat
 OTHER YEAR ROOF MATERIAL Not visible
 DATESOURCE Building Permit FOUNDATION Concrete - poured
 WALL MATERIAL (current) Concrete - block PORCH
 WALL MATERIAL 2 (current) Brick WINDOW MATERIAL Metal
 WALL MATERIAL (original) Concrete - block WINDOW MATERIAL
 WALL MATERIAL 2 (original) WINDOW TYPE Fixed/awning
 WINDOW CONFIG 6-light

SIGNIFICANT FEATURES Two garage bays on short (street) end; pedestrian door on long (4 bay) façade

ALTERATIONS Replacement overhead garage doors in bay; 2 story yellow brick southwest corner addition (approx. 86x78) to existing repair garage that has one full height garage bay [Permit #38618 (1971)]; metal antennae

Original permit #34428 (1965)--33x61 ordinary construction repair garage

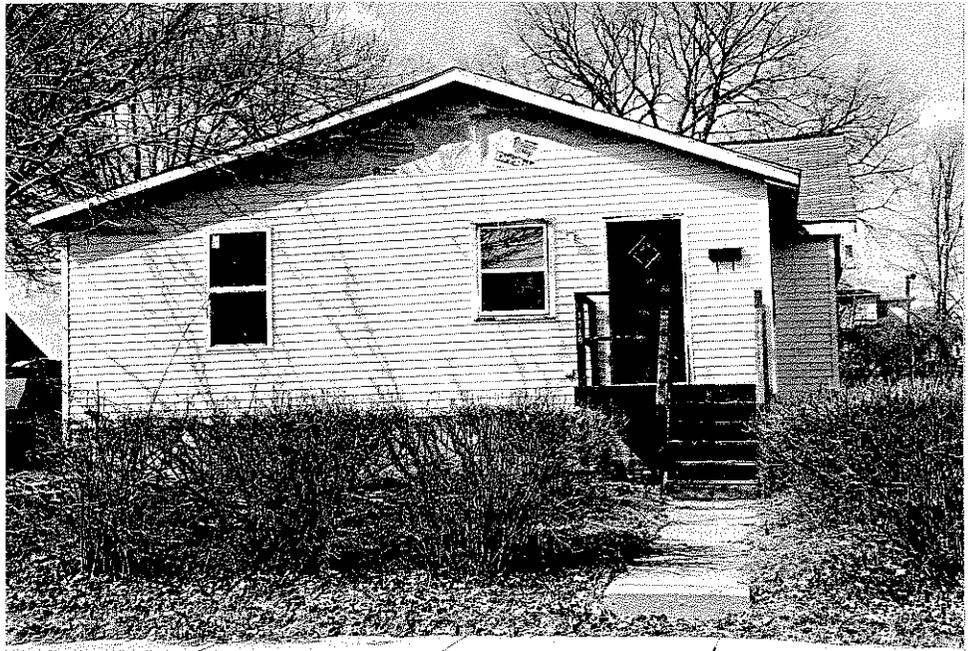
CATEGORY building CURRENT FUNCTION Domestic - single dwelling
 CONDITION good HISTORIC FUNCTION Domestic - single dwelling
 INTEGRITY major alterations and/or addition(s) REASON for SIGNIFICANCE
 STOREFRONT INTEGRITY
 SECONDARY STRUCTURE

ARCHITECTURAL CLASSIFICATION No style PLAN rectangular
 DETAILS NO OF STORIES 1
 BEGINYEAR ROOF TYPE Cross gable
 OTHER YEAR 2004 ROOF MATERIAL Asphalt - shingle
 DATESOURCE Surveyor FOUNDATION Limestone/parged
 WALL MATERIAL (current) Vinyl PORCH
 WALL MATERIAL 2 (current) WINDOW MATERIAL Aluminum
 WALL MATERIAL (original) Wood WINDOW MATERIAL
 WALL MATERIAL 2 (original) WINDOW TYPE double hung
 WINDOW CONFIG 1/1

SIGNIFICANT FEATURES Original part of house may have been an upright and wing; now only wing portion has survived

ALTERATIONS Fire in June 2004; currently being renovated; vinyl siding; aluminum windows; rebuilt front gable portion with concrete block foundation [permit # B82-226 (1982)-12x14 front room addition]

Additional permits -- #3888 (1928)--rear addition; #29944
(1966)--Aluminum siding
