Barber-Colman

ILLINOIS URBAN ARCHITECTURAL AND HISTORICAL SURVEY CONTINUATION SHEET

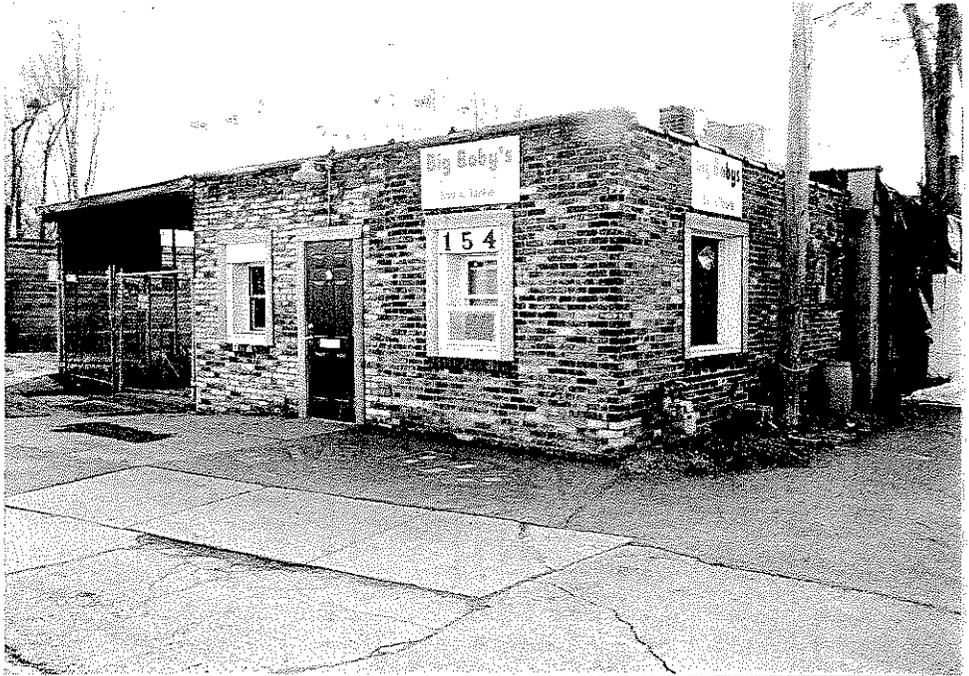
| CATEGORY | <input type="text" value="building"/> | CURRENT FUNCTION | <input type="text" value="Commerce/Trade - business"/> |
| CONDITION | <input type="text" value="fair"/> | HISTORIC FUNCTION | <input type="text" value="Unknown"/> |
| INTEGRITY | <input type="text" value="minor alterations"/> | REASON for SIGNIFICANCE | <input type="text"/> |
| SECONDARY STRUCTURE | <input type="text" value="detached garage"/> <input type="text" value="detached garage"/> | | |

| ARCHITECTURAL CLASSIFICATION | <input type="text" value="Industrial"/> | PLAN | <input type="text" value="square"/> |
| BEGINYEAR | <input type="text" value="c. 1915"/> | ROOF TYPE | <input type="text" value="Flat"/> |
| WALL MATERIAL (current) | <input type="text" value="Brick"/> | PORCH | <input type="text" value="Side car port"/> |
| WALL MATERIAL 2 (current) | <input type="text"/> | WINDOW MATERIAL | <input type="text" value="Vinyl"/> |

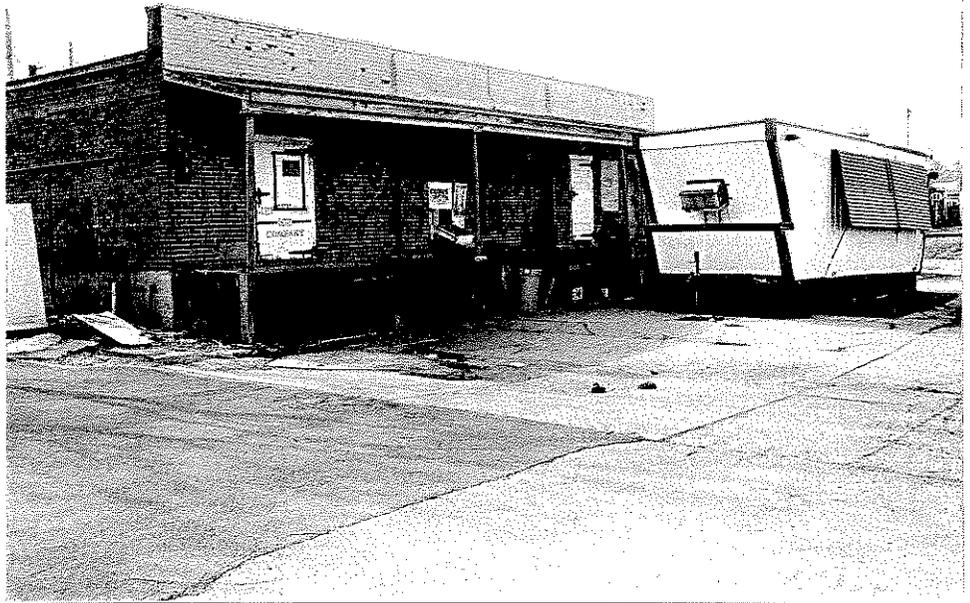
| CATEGORY | <input type="text" value="building"/> | CURRENT FUNCTION | <input type="text" value="Industry/Processing/Extraction"/> |
| CONDITION | <input type="text" value="fair"/> | HISTORIC FUNCTION | <input type="text" value="Industry/Processing/Extraction"/> |
| INTEGRITY | <input type="text" value="minor alterations and addition(s)"/> | REASON for SIGNIFICANCE | <input type="text"/> |

| ARCHITECTURAL CLASSIFICATION | <input type="text" value="Industrial - Storage"/> | PLAN | <input type="text" value="rectangular"/> |
| BEGINYEAR | <input type="text" value="c. 1925"/> | ROOF TYPE | <input type="text" value="Flat"/> |
| WALL MATERIAL (current) | <input type="text" value="Brick"/> | PORCH | <input type="text" value="Full front"/> |
| WALL MATERIAL 2 (current) | <input type="text" value="Common Brick"/> | WINDOW MATERIAL | <input type="text" value="Boarded"/> |

Building permits: permit #4680 (1931)--remove old building and remodel front hall; remodel [Permit #4768 (1931)]; install new ceiling joists [Permit #19944 (1955)]; remodel masonry garage & install new overhead door [Permit #21690 (1959)]

Southeast corner of River and Morgan; concrete parking pad at front; chain link fence around lot to east

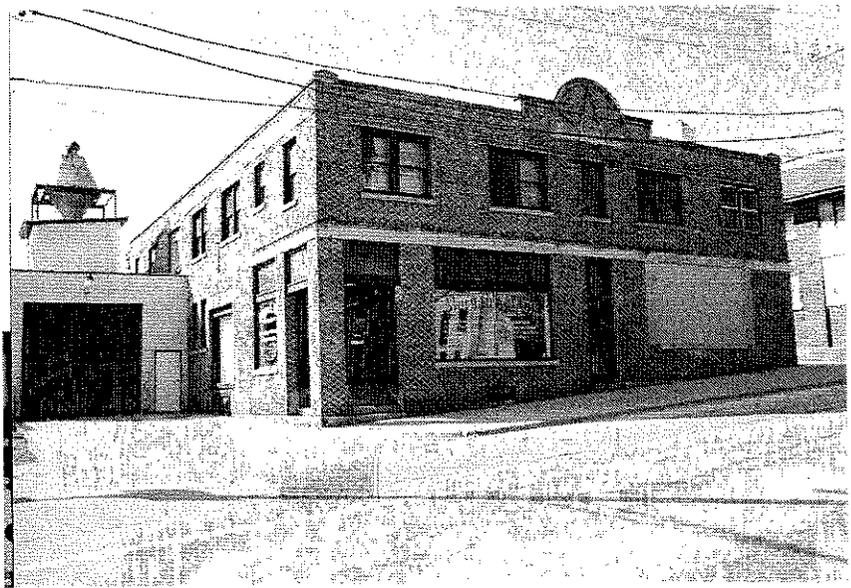
| CATEGORY | <input type="text" value="building"/> | CURRENT FUNCTION | <input type="text" value="Commerce/Trade - business"/> |
| CONDITION | <input type="text" value="good"/> | HISTORIC FUNCTION | <input type="text" value="Commerce/Trade - business"/> |
| INTEGRITY | <input type="text" value="minor alterations and addition(s)"/> | REASON for SIGNIFICANCE | <input type="text" value="Notable Two Part Commercial Block with interesting brickwork and arched parapet, together with distinctive corner storefront entry."/> |
| STOREFRONT INTEGRITY | <input type="text" value="Minor alterations"/> | | |

| ARCHITECTURAL CLASSIFICATION | <input type="text" value="Two Part Commercial Block"/> | PLAN | <input type="text" value="rectangular"/> |
| BEGINYEAR | <input type="text" value="c. 1910"/> | ROOF TYPE | <input type="text" value="Flat"/> |

Stone frieze above storefront level; recessed corner entry with wood paneled door on angle; historic wood display windows w/ prism glass transoms; central entry to second floor; prism glass transom over doorway

One display window opening blocked in

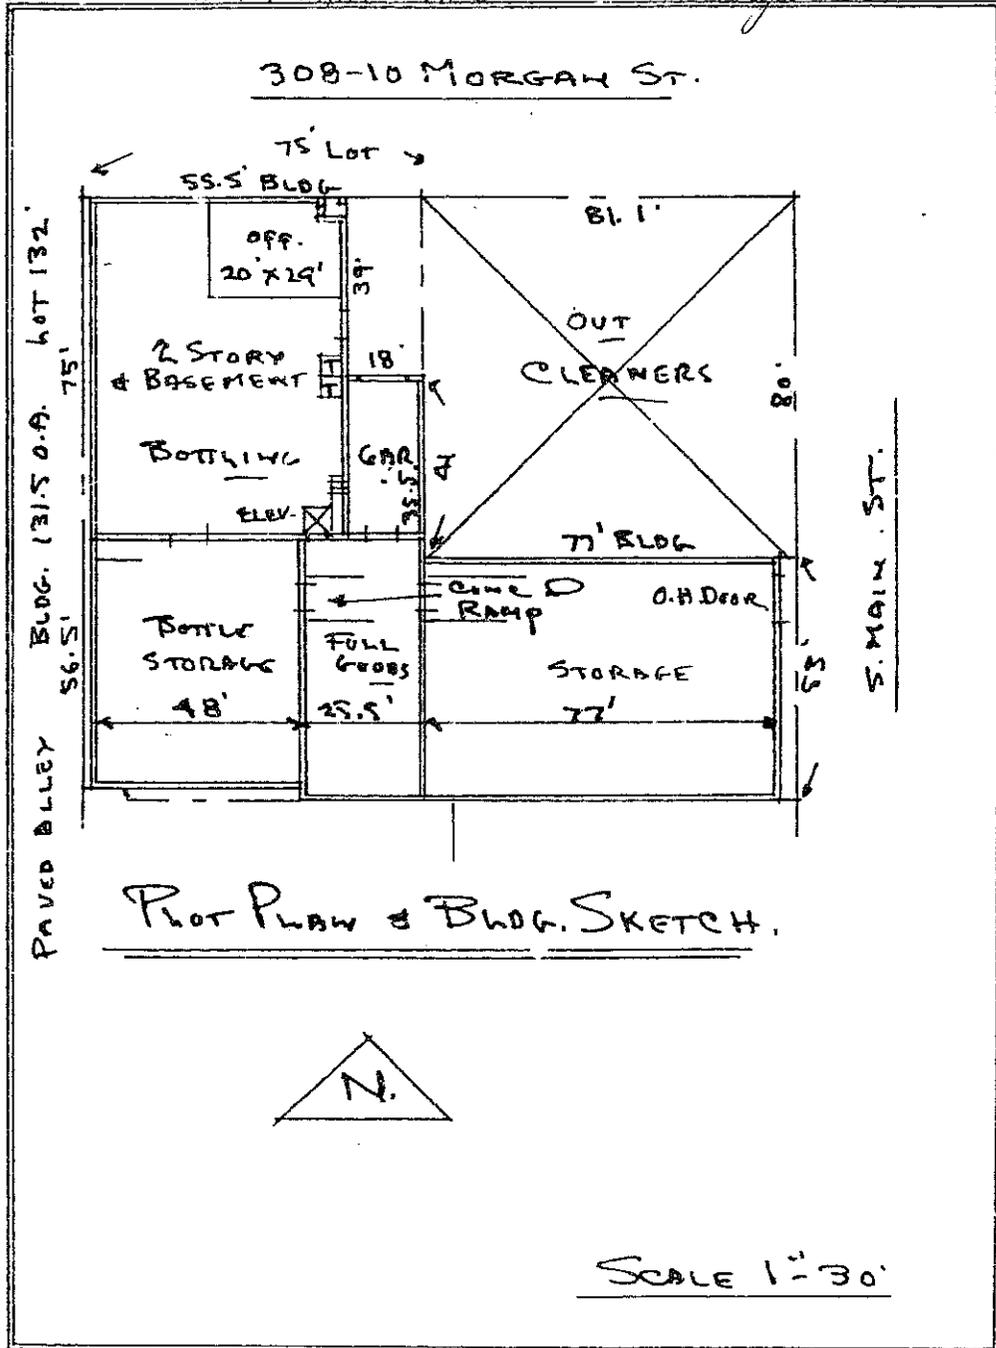
Plot Plan & Bldg. Sketch.

#21191 (3/31/1953)—24x48-4 Aluminum bottling works

#6397 (1937)—new concrete floor; #2366 (1961)—south side addition (approx. 70x60) for storage
