City of ROCKFORD

ILLINOIS URBAN ARCHITECTURAL AND HISTORICAL SURVEY CONTINUATION SHEET

Barber-Colman

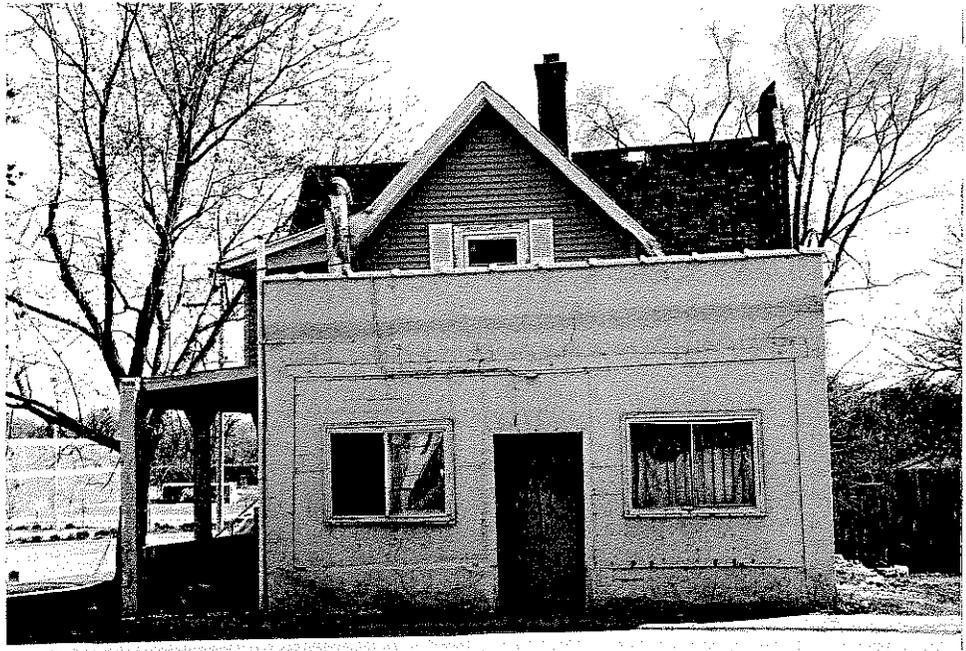
1 story storefront with center recessed entry

Stuccoed facade; downsized and infilled storefront windows

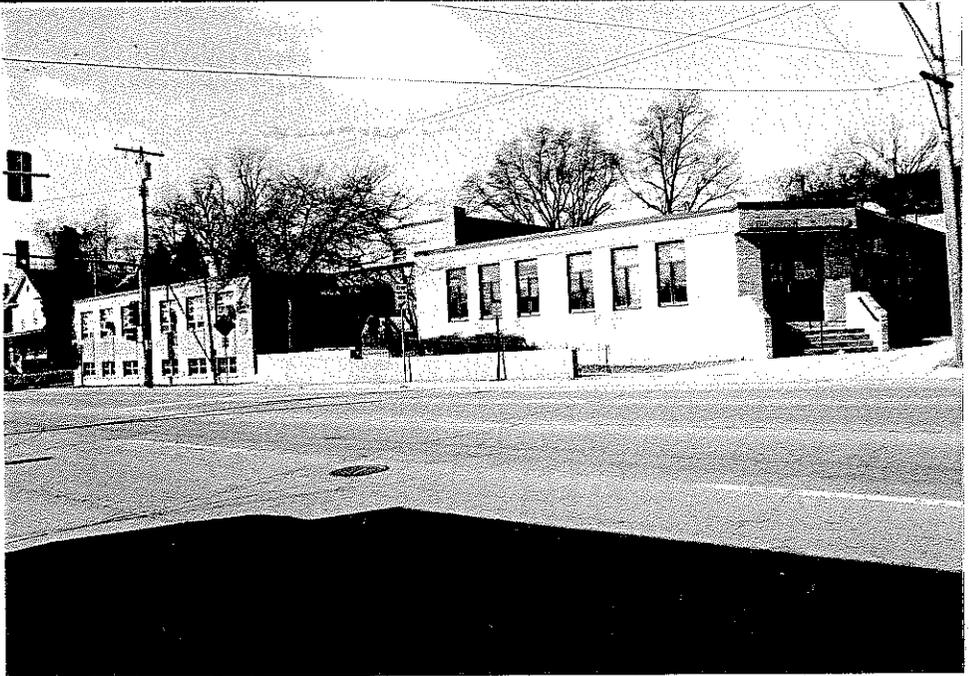
CATEGORY	<input type="text" value="building"/>	CURRENT FUNCTION	<input type="text" value="Religion - religious facility"/>
CONDITION	<input type="text" value="excellent"/>	HISTORIC FUNCTION	<input type="text" value="Religion - religious facility"/>
INTEGRITY	<input type="text" value="minor alterations and addition(s)"/>	REASON for SIGNIFICANCE	<input type="text"/>
STOREFRONT INTEGRITY	<input type="text"/>		
SECONDARY STRUCTURE	<input type="text"/>

ARCHITECTURAL CLASSIFICATION	<input type="text" value="Freestanding/Institutional"/>	PLAN	<input type="text" value="irregular"/>
DETAILS	<input type="text" value="International style"/>	NO OF STORIES	<input type="text" value="1.5"/>
BEGINYEAR	<input type="text" value="1968"/>	ROOF TYPE	<input type="text" value="Flat"/>
OTHER YEAR	<input type="text" value="1979"/>	ROOF MATERIAL	<input type="text" value="Not visible"/>
DATESOURCE	<input type="text" value="Cornerstone"/>	FOUNDATION	<input type="text" value="Concrete - poured"/>
WALL MATERIAL (current)	<input type="text" value="Brick (common)"/>	PORCH	<input type="text"/>
WALL MATERIAL 2 (current)	<input type="text"/>	WINDOW MATERIAL	<input type="text" value="Aluminum"/>
WALL MATERIAL (original)	<input type="text" value="Brick (common)"/>	WINDOW MATERIAL	<input type="text"/>
WALL MATERIAL 2 (original)	<input type="text"/>	WINDOW TYPE	<input type="text" value="casement"/>

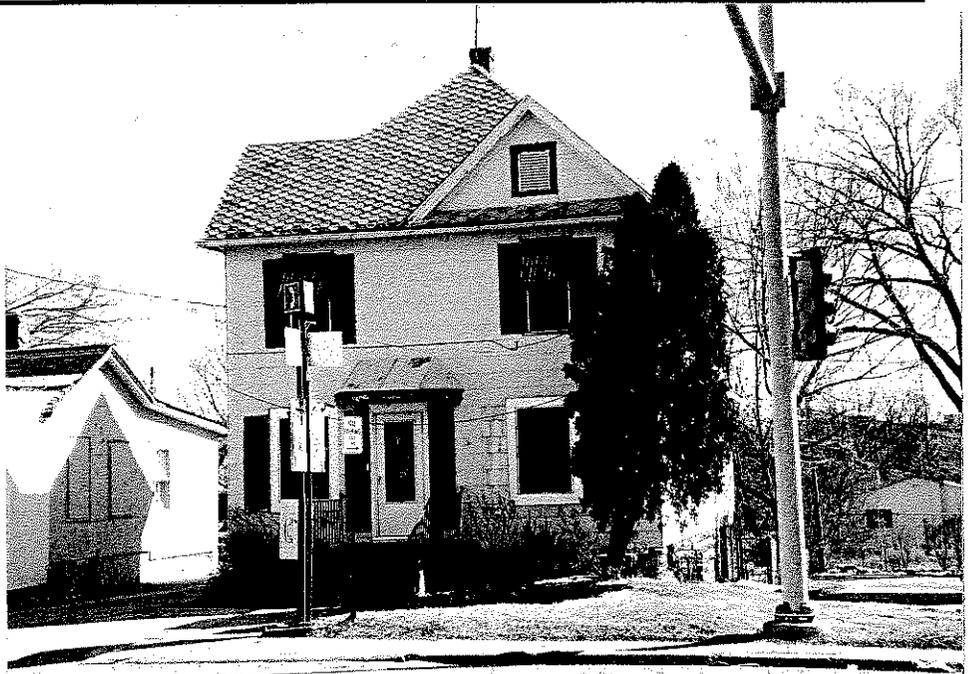
STREET # 1516

Downsized and replacement Aluminum windows; asbestos shingle siding [#10313 (1944)--asbestos shingle siding]; porch removed (possibly full front); and hipped canopy over front entry added; shutters added; replacement front door; concrete front steps and wrought iron rail; some boarded windows on side facades; partially enclosed rear porch

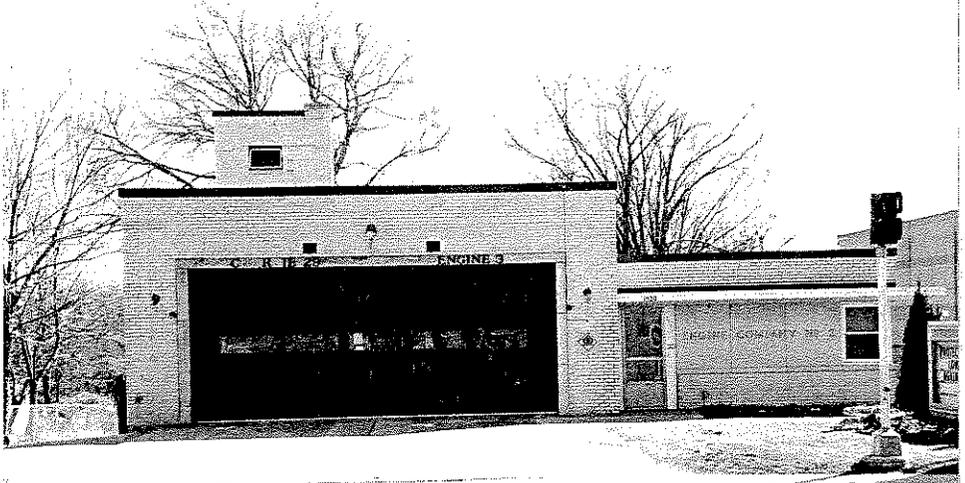
ROLL1	3
FRAMES1	32
ROLL2	
FRAMES2	
ROLL3	
FRAMES3	
DIGITAL PHOTO ID	e:\main1520s.jpg

CATEGORY	<input type="text" value="structure"/>	CURRENT FUNCTION	<input type="text" value="Government - fire station"/>
CONDITION	<input type="text" value="good"/>	HISTORIC FUNCTION	<input type="text" value="Government - fire station"/>
INTEGRITY	<input type="text" value="not altered"/>	REASON for SIGNIFICANCE	<input type="text"/>
STOREFRONT INTEGRITY	<input type="text"/>		
SECONDARY STRUCTURE	<input type="text"/>

ARCHITECTURAL CLASSIFICATION	<input type="text" value="Fire Station/International Style"/>	PLAN	<input type="text" value="rectangular"/>
DETAILS	<input type="text"/>	NO OF STORIES	<input type="text" value="1.5"/>
BEGINYEAR	<input type="text" value="1954"/>	ROOF TYPE	<input type="text" value="Flat"/>
OTHER YEAR	<input type="text"/>	ROOF MATERIAL	<input type="text" value="Not visible"/>
DATESOURCE	<input type="text" value="Building Permit"/>	FOUNDATION	<input type="text" value="Concrete"/>
WALL MATERIAL (current)	<input type="text" value="Brick"/>	PORCH	<input type="text"/>
WALL MATERIAL 2 (current)	<input type="text"/>	WINDOW MATERIAL	<input type="text" value="Aluminum"/>
WALL MATERIAL (original)	<input type="text" value="Brick"/>	WINDOW MATERIAL	<input type="text" value="Glass Block"/>
WALL MATERIAL 2 (original)	<input type="text"/>	WINDOW TYPE	<input type="text" value="double hung/fixe"/>
SIGNIFICANT FEATURES	<input type="text" value="Overhang at front entry"/>
