SILT FENCE

Properly installed and maintained

Improper installation and lack of maintenance

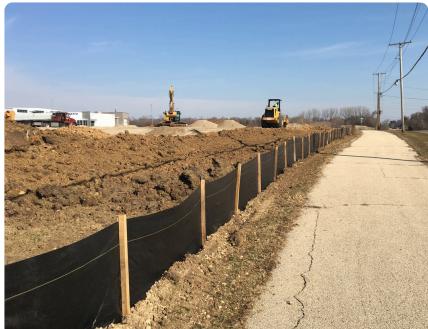
The silt fence is properly installed meaning it is trenched and back filled.

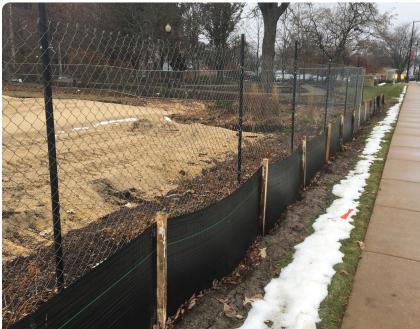
The silt fence is installed in the proper location.

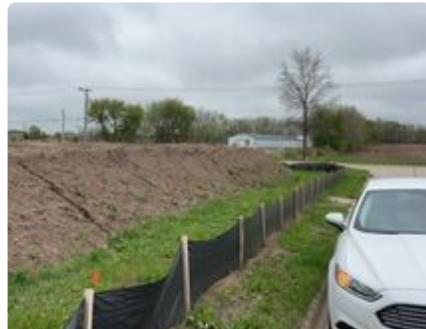
The silt fence is installed and being maintained.

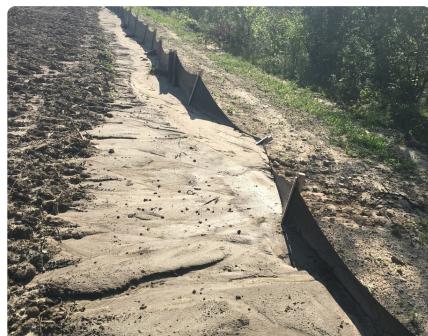
The silt fence is properly installed but needs maintenance. Once sediment is half way up the silt fence the sediment needs to be removed and the silt fence needs to be repaired.

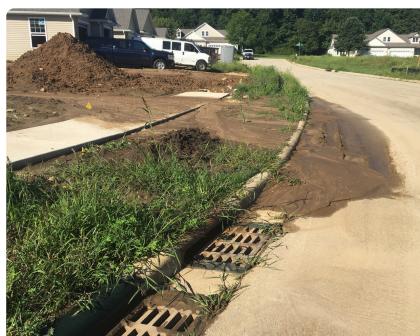
Silt fence was never installed and therefore sediment is leaving the site.

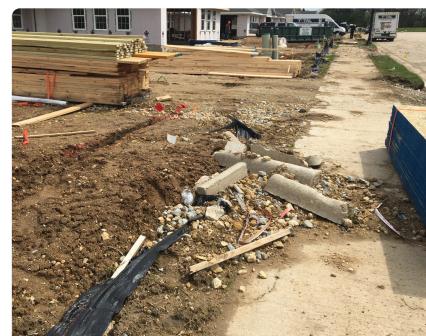
Silt fence was installed improperly and never maintained. Construction debris knocked the silt fence over and sediment is leaving the site.
